Seawall Materials & Methods Feasibility Study City of Punta Gorda, Florida

Final Report
March 2021

Taylor Engineering, Inc.
1800 2nd St, Ste. 714
Sarasota, Florida 34236
(941) 702-5871

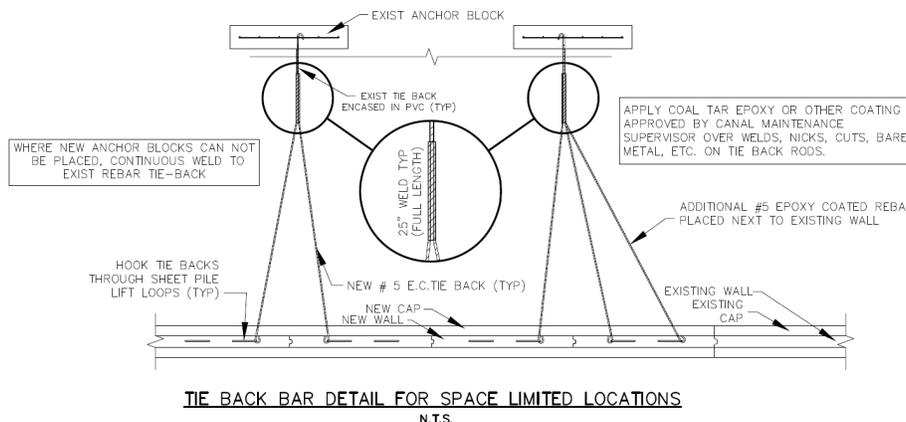
Figure 6.2 Tie-back Detail

Tie-back System: The City is currently using rebar tie-backs that are specified as epoxy coated or steel with PVC encasement. The use of epoxy coated reinforcement has had mixed results in marine applications. At one point, the FDOT stopped using epoxy coated rebar due to performance concerns. Considering both potential loading and corrosion rates in the marine environment, the #5 rebar for the anchor rods as shown in Figure 6.2, is undersized, particularly where site conditions require greater sheet pile lengths. Notably, the size and spacing of the anchor rods typically change/increase with increasing wall height. The current design allows for welding of new anchor rods to the existing ones. The welds can present an area of metal with a significantly reduced cross section, thereby making the welds very susceptible to loss of strength due to corrosion.

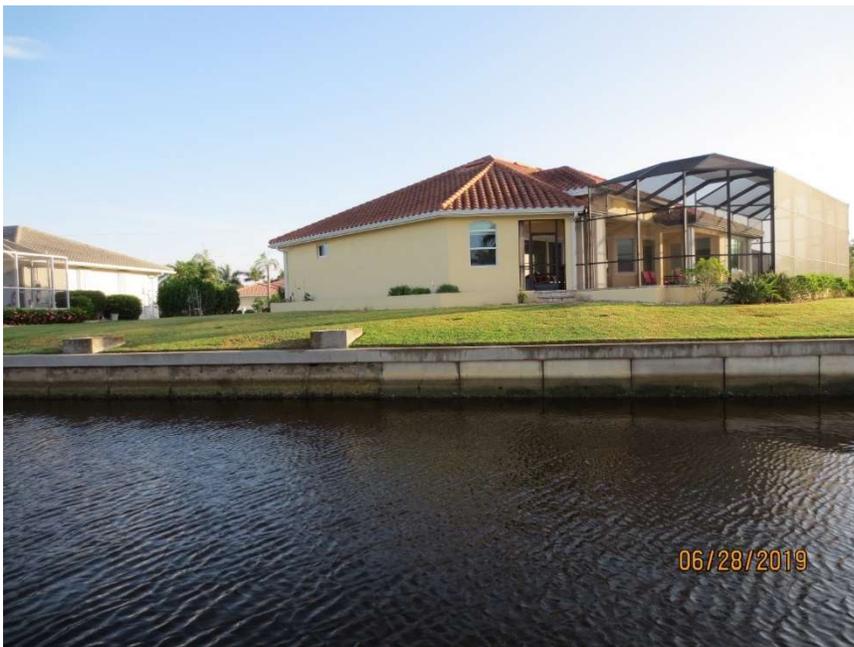
Location 1: 2803 Sancho Panza Ct

Left: Original Panels with Epoxy Coated Rebar Cap Replacement

Right: 1st Generation MMFX, 2012 (lower weep hole, prior Irma)

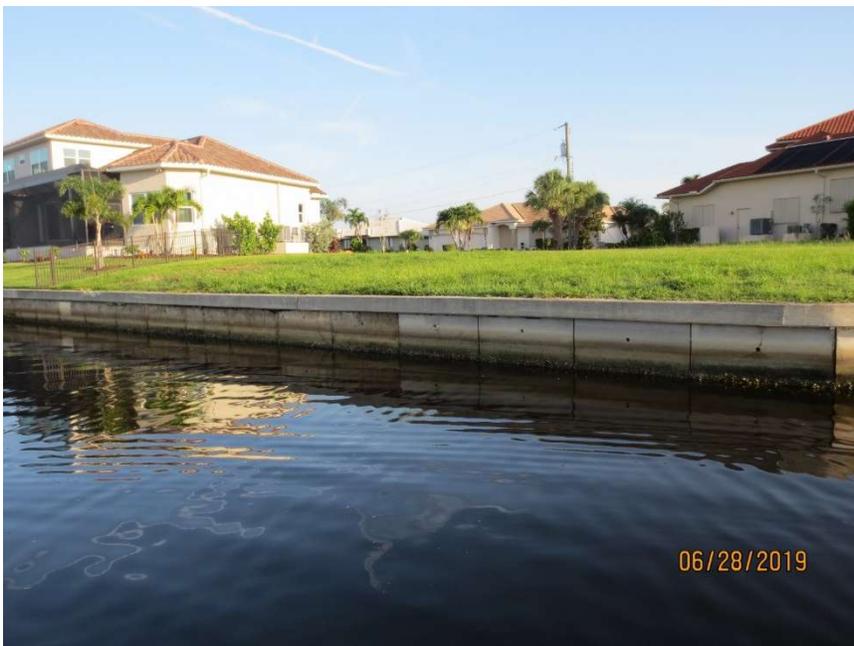
Location 2: 2803 Don Quixote Dr

Left: Original Panels with Epoxy Coated Rebar Cap Replacement

Right: Epoxy Coated Rebar seawall

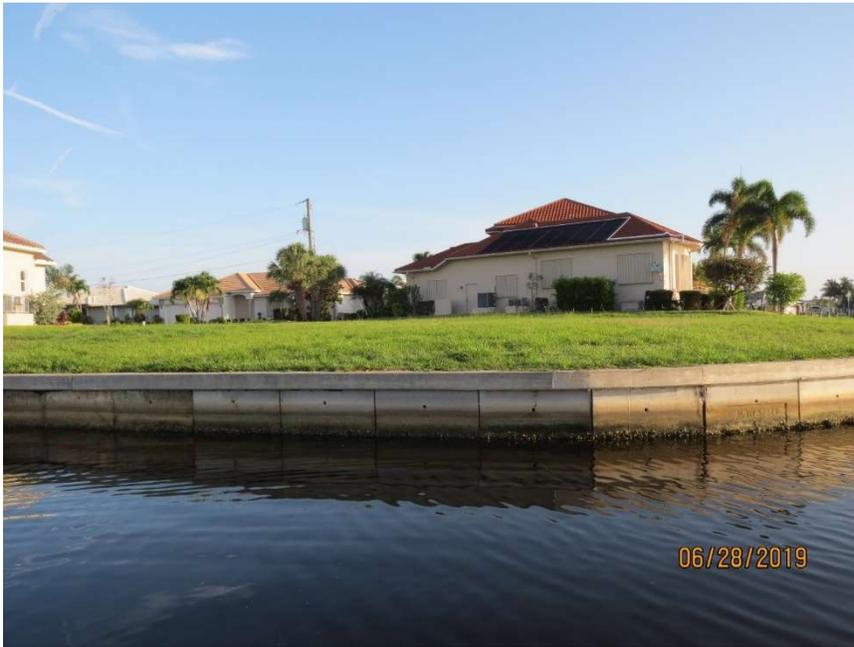
Location 2: 2803 Don Quixote Dr

Left: Original Panels with Epoxy Coated Rebar Cap Replacement

Right: Epoxy Coated Rebar seawall, 5 Panels left out Original, then more Replacements

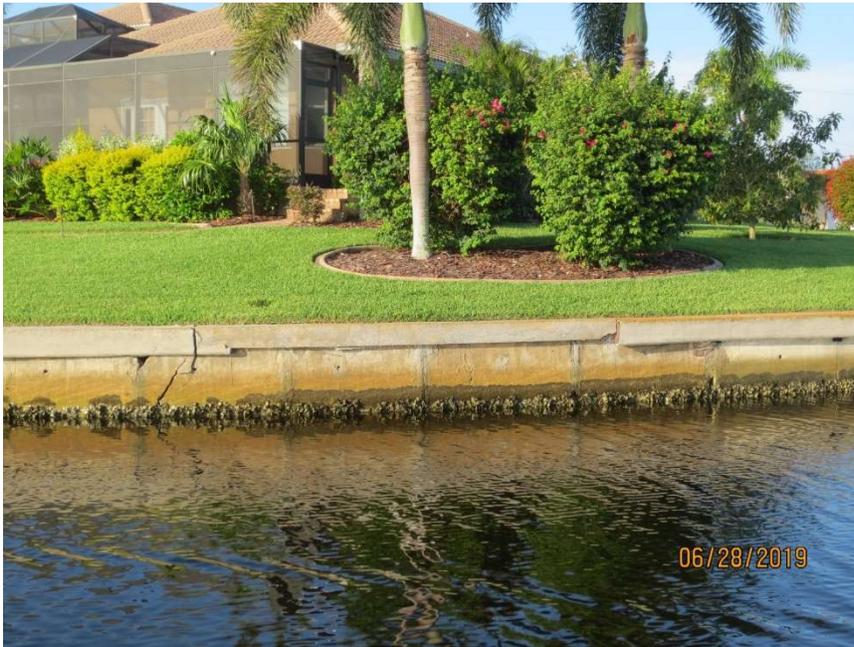
Location 4: 2800 Via Paloma Dr

Larger Caps used to stop in the middle of an old panel. Typical panel breakage occurred at these locations because differential loading. Now new Cap installation ends where new installation ends to avoid further damage to the panel.

Right: Panel union void below grout patch

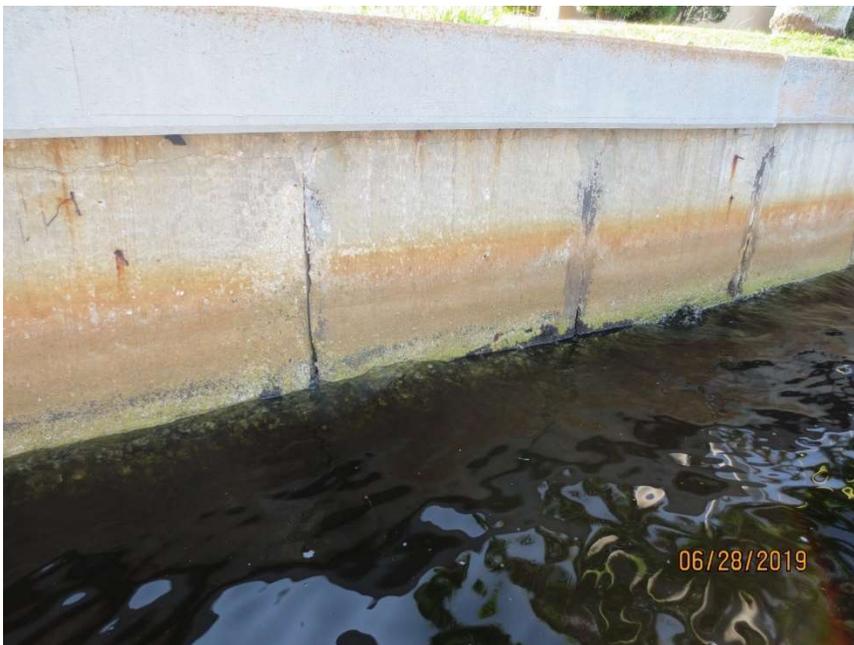
Location 10: 7 Hibiscus Dr

Longitudinal cracks below Cap

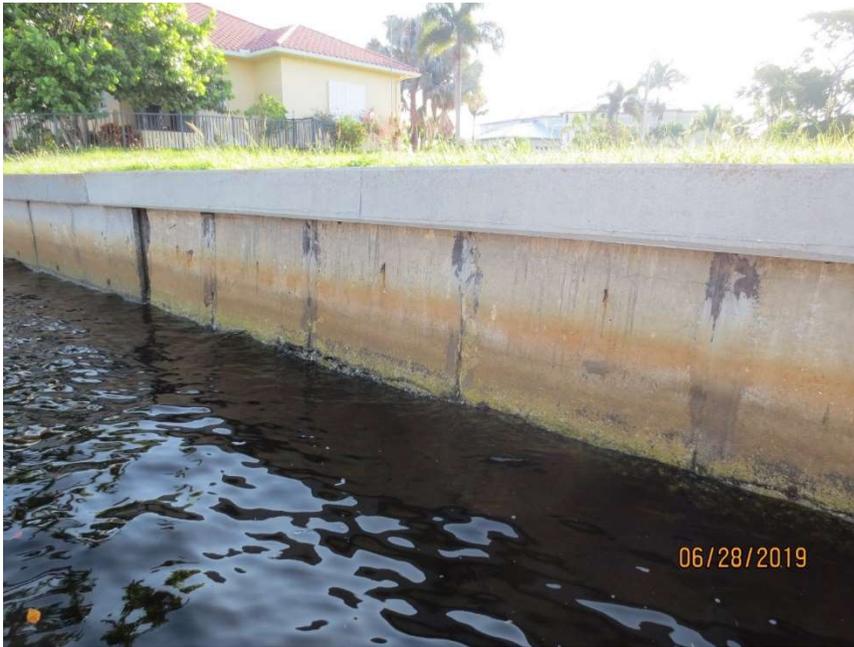
Location 10: 7 Hibiscus Dr

Severe Rating, Crack by waterline

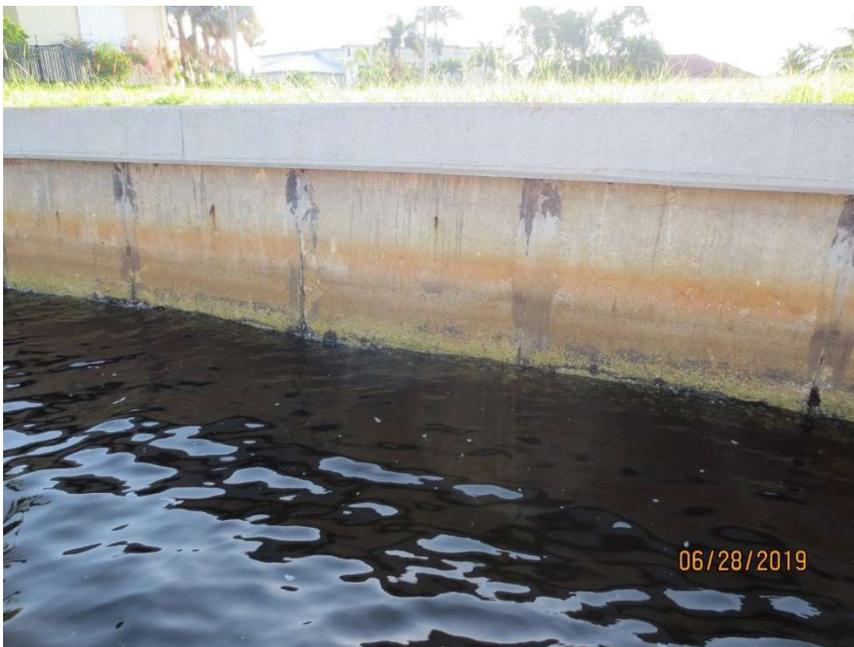
Location 10: 7 Hibiscus Dr

Severe Rating, Crack by waterline

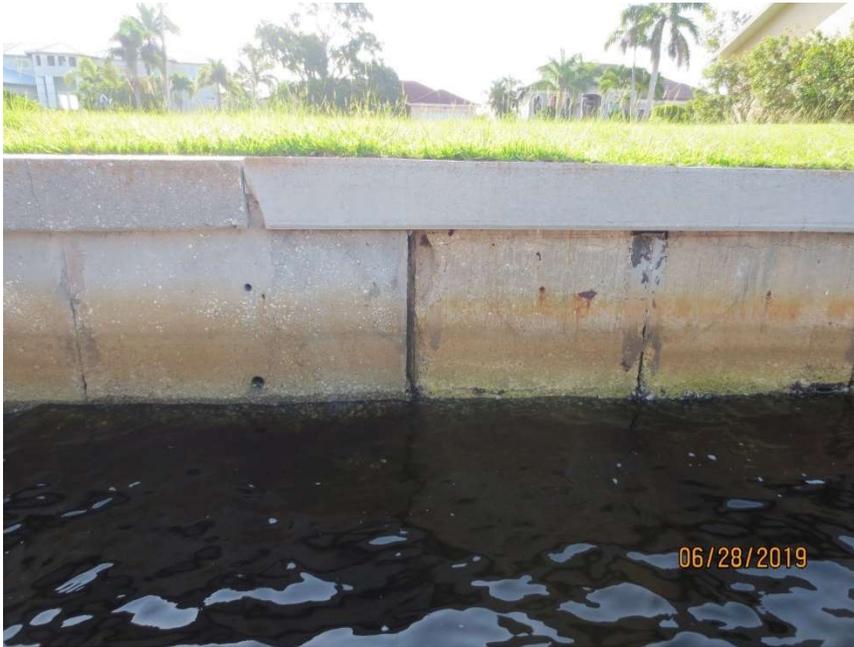
Location 10: 7 Hibiscus Dr

Old and newer panel separation

Cap end spall

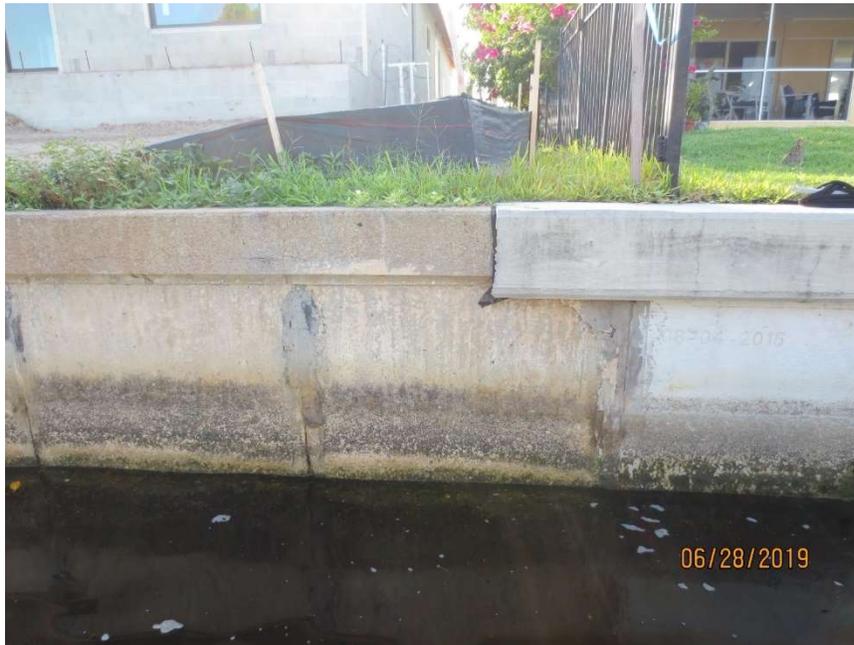
Location 11: 29 Ocean Dr

Right: Newer construction in 2015 with MMFX Rebar. Cap extends to old seawall and crack the panel below.

Left: Original seawall with overall condition 4 and waterline cracking.

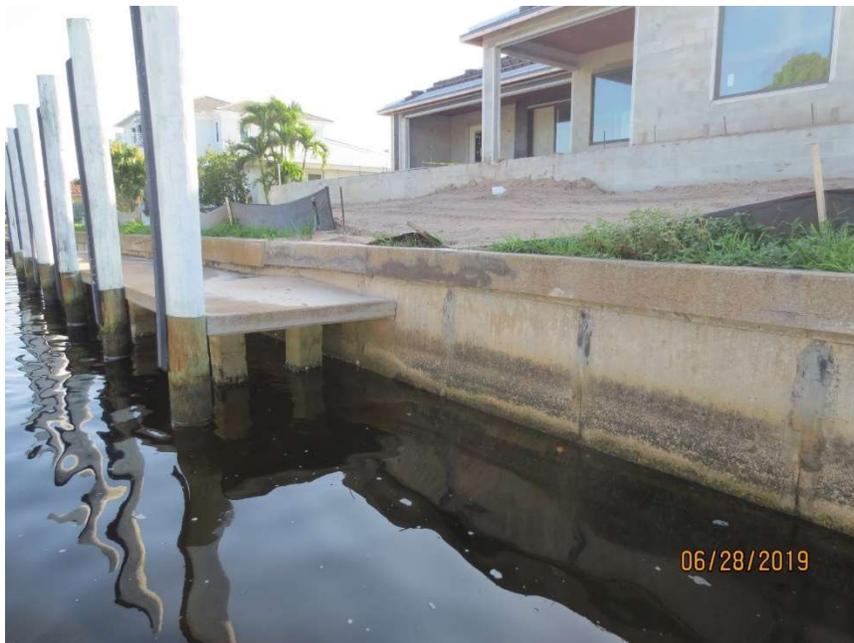
Location 11: 29 Ocean Dr

Original seawall with overall condition 4 and waterline cracking.

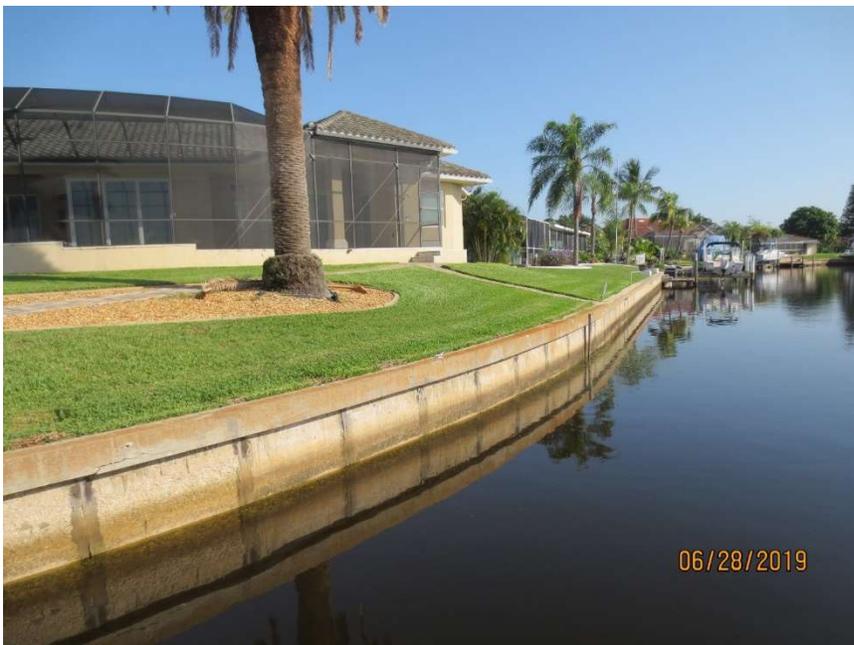
Location 15: 1793 Belle Ct

East side of the wall in better condition.

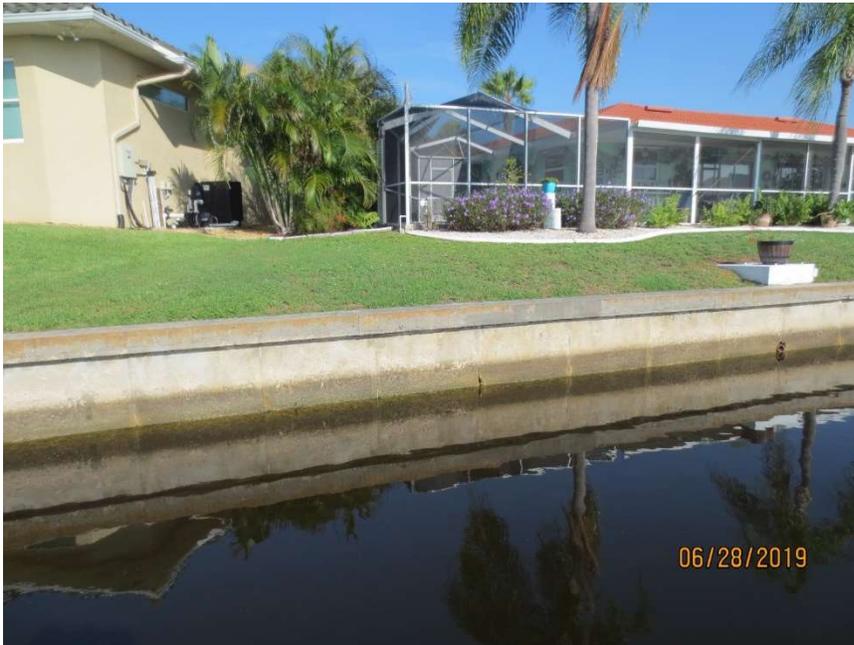
Location 15: 1793 Belle Ct

East side of the wall in better condition and cap patched with grout.

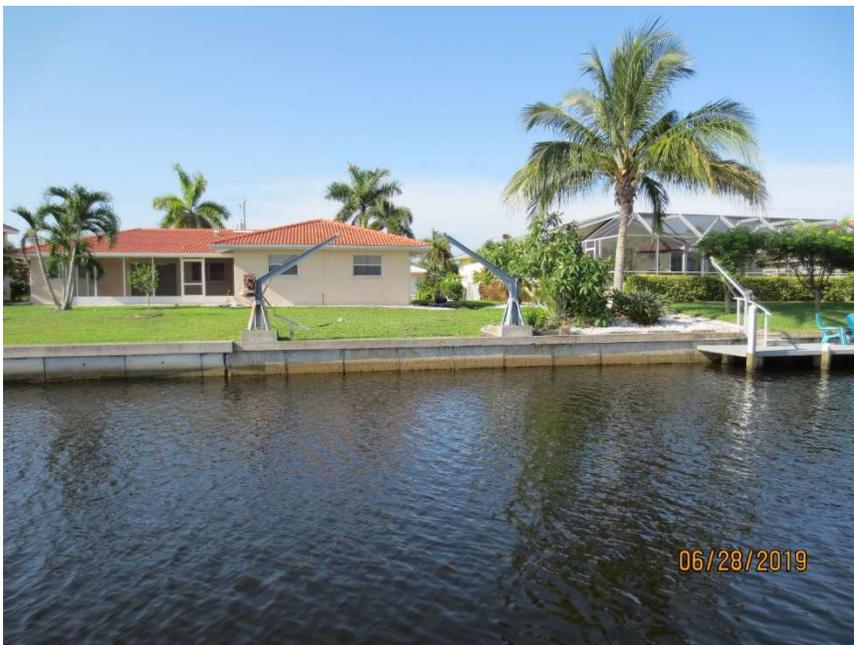
Location 16: 2096 El Cerito Ct

Waterline cracking almost failure condition

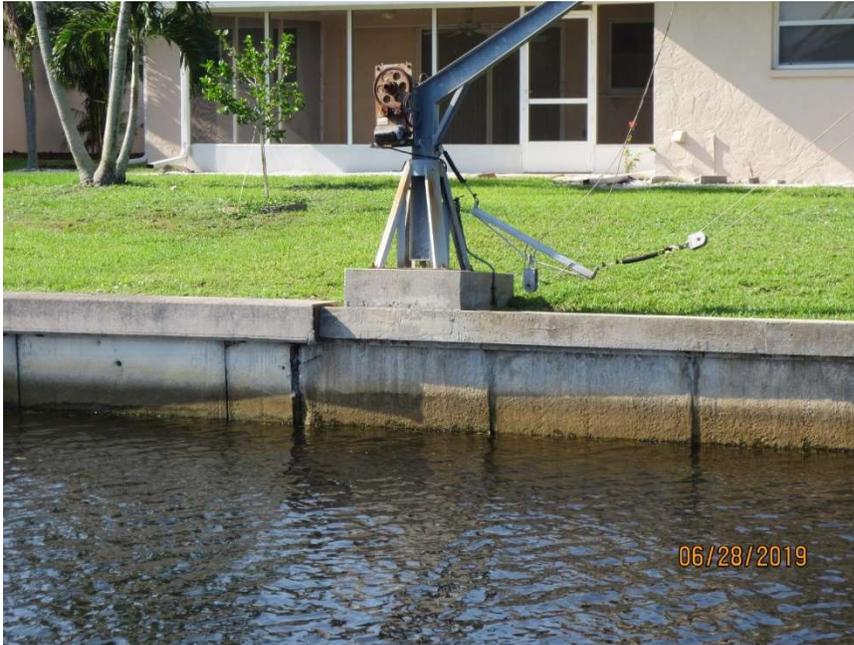
Location 16: 2096 El Cerito Ct

Waterline cracking almost failure condition

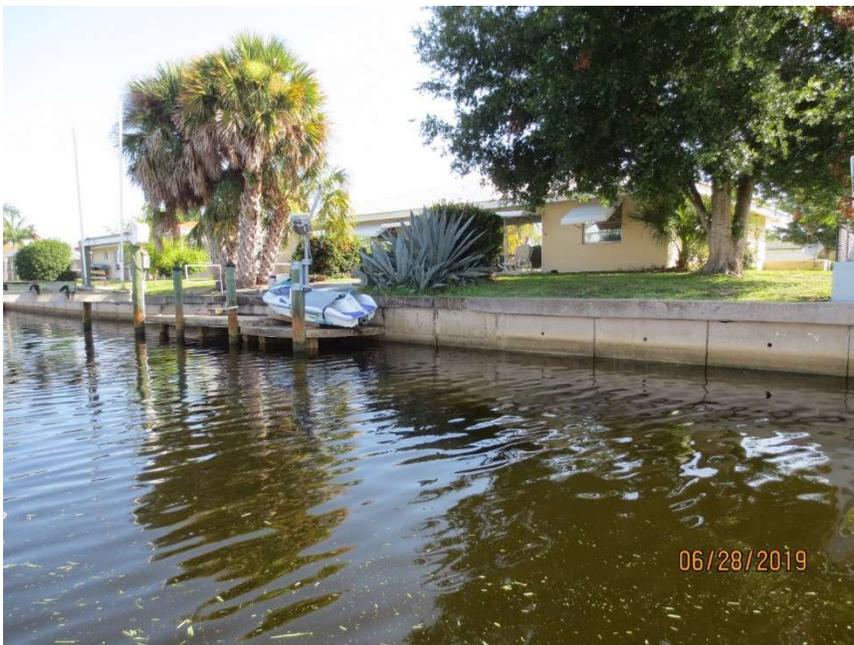
Location 17: 325 Belvedere Ct

Overall Condition 4, 75% cracks, below waterline.

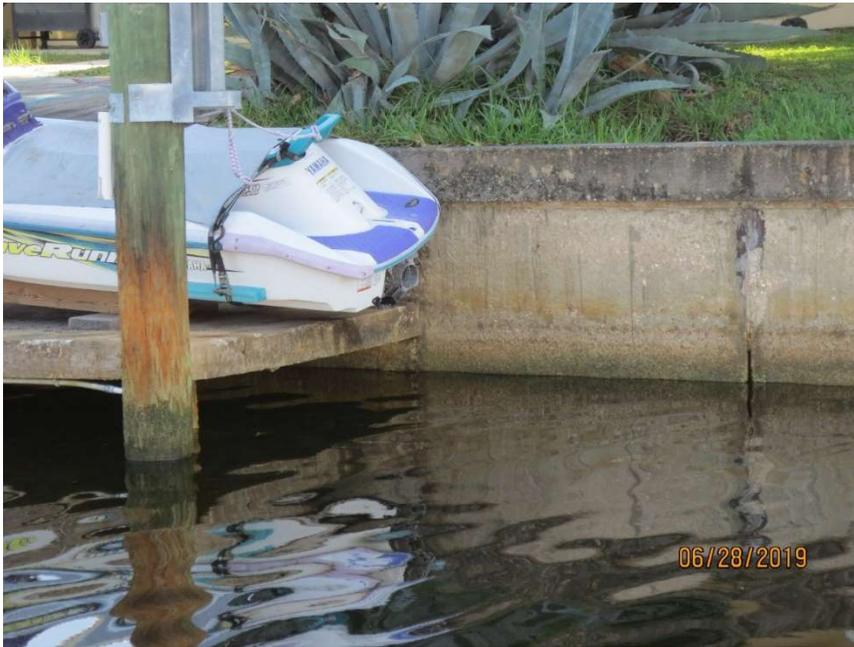
Location 17: 325 Belvedere Ct

Overall Condition 4, 75% cracks, below waterline.

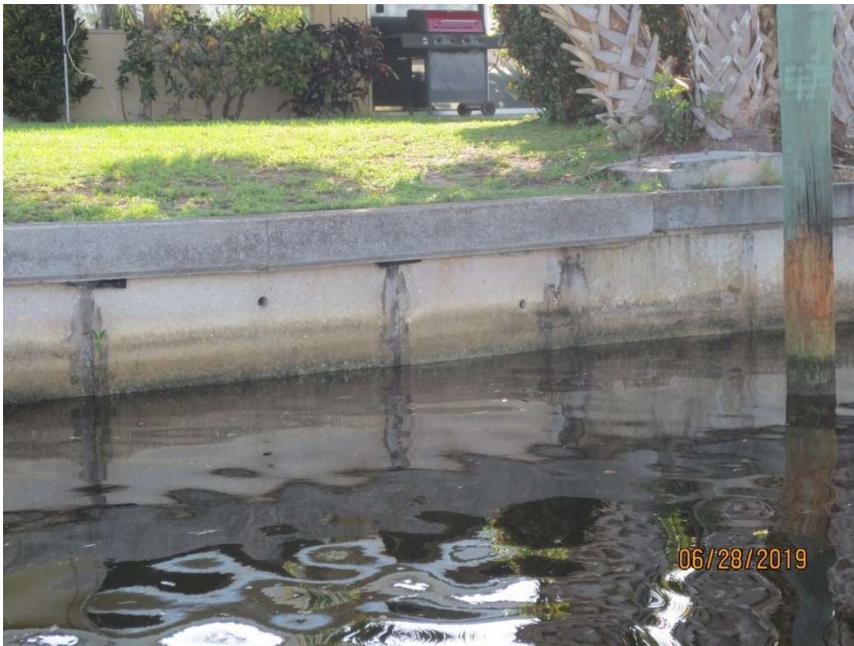
Location 17: 325 Belvedere Ct

Overall Condition 4, 75% cracks, below waterline.

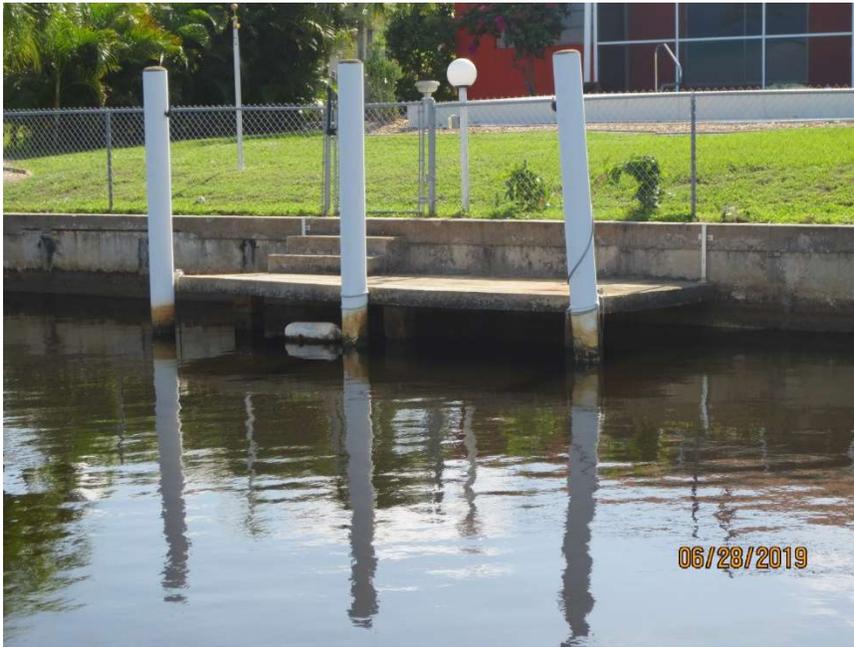
Location: Eastern canal on PGI-NW2

Dock supported by 3 squared concrete piles. Slab pinned to wall panels.

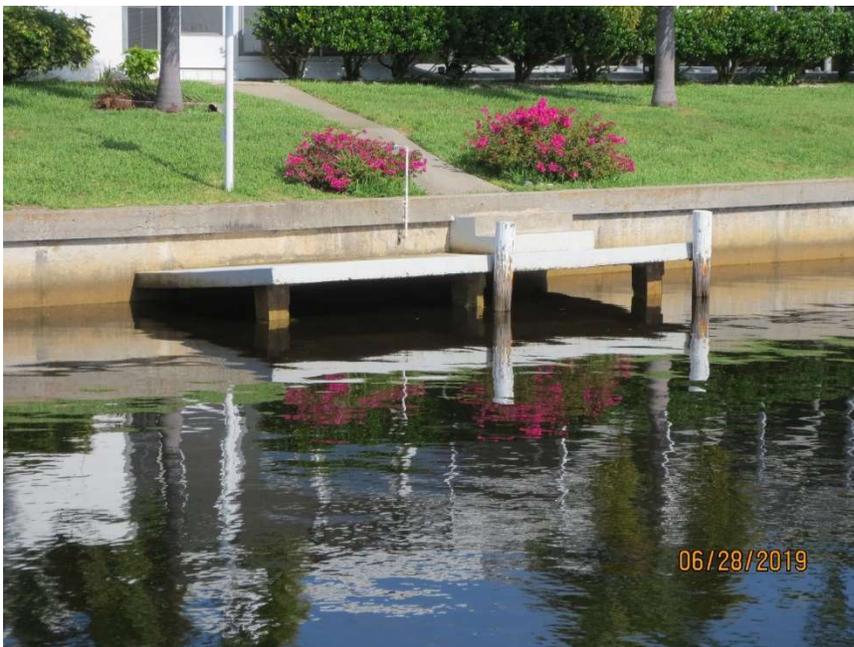
Location: Eastern canal on PGI-NW2

Dock supported by 3 squared concrete piles. Slab pinned to wall panels. Typical damage condition of this design is an inclined slab.

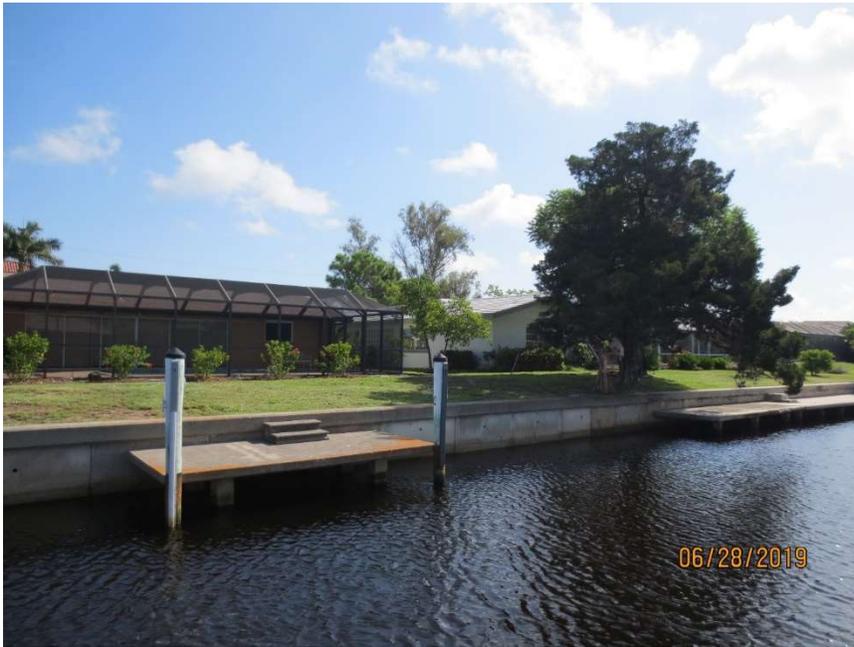
Location 18: 2131 Bayou Rd

Left: MMFX Rebar seawall installed around 2012 to be replaced again.

Right: Bird nest of blue heron and other birds on cypress tree. Tree needs to come out, too close to the seawall.

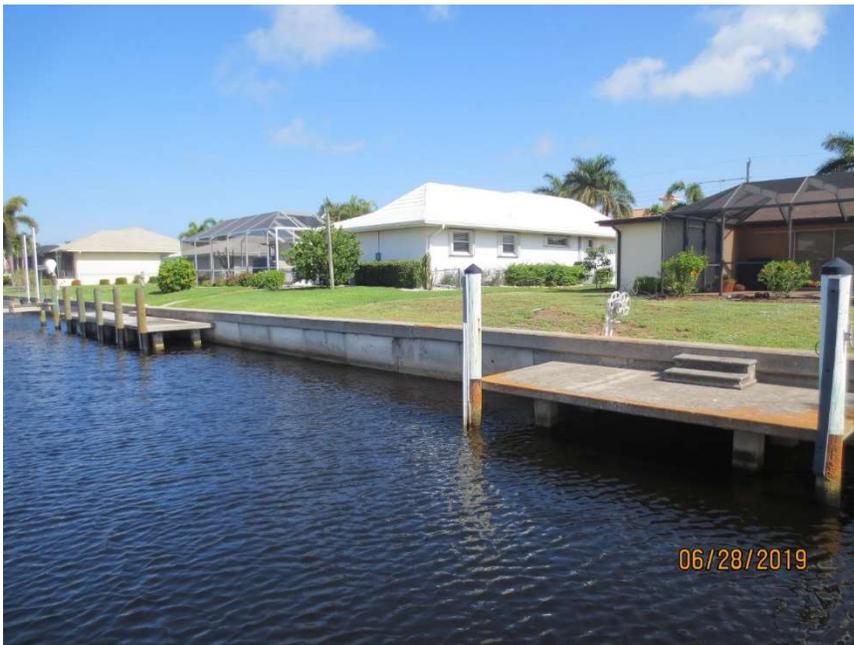
Location 18: 2131 Bayou Rd

Left: MMFX Rebar seawall installed around 2012 to be replaced again.

Wall leaning waterward, depressions, tie back rods possibly broken.

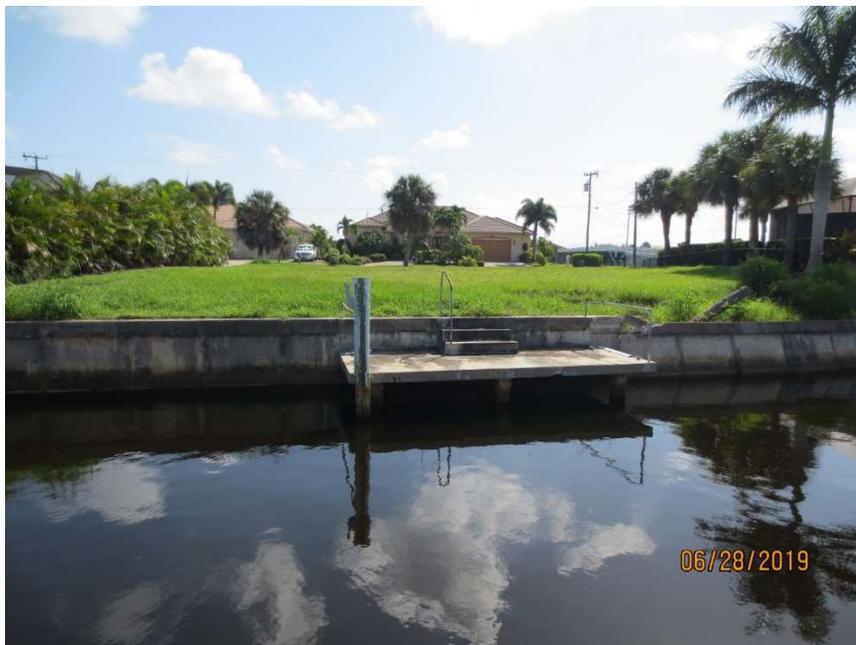
Location 19: 185 Gulfview Rd

Right: Seawall typical Irma failure (toe kicked out) to be replaced.

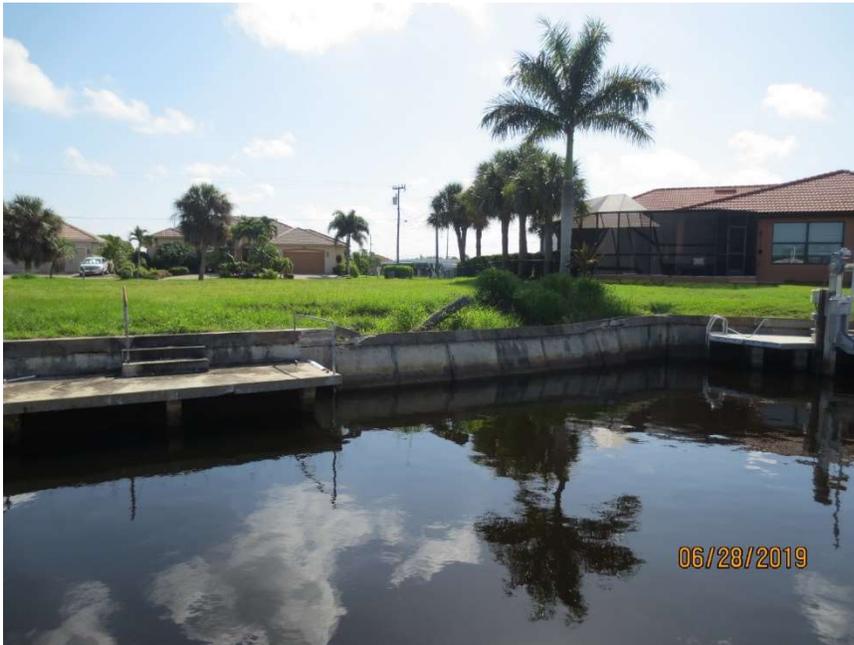
Location 19: 185 Gulfview Rd

Right: Seawall typical Irma failure (toe kicked out) to be replaced.

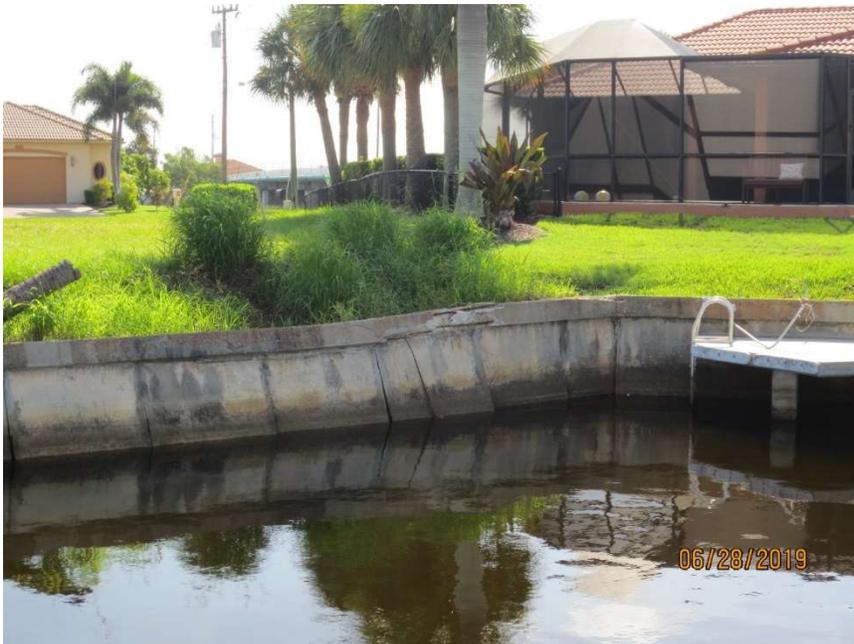
Location 19: 185 Gulfview Rd

Right: Seawall typical Irma failure (toe kicked out) to be replaced.

Large depression behind wall.

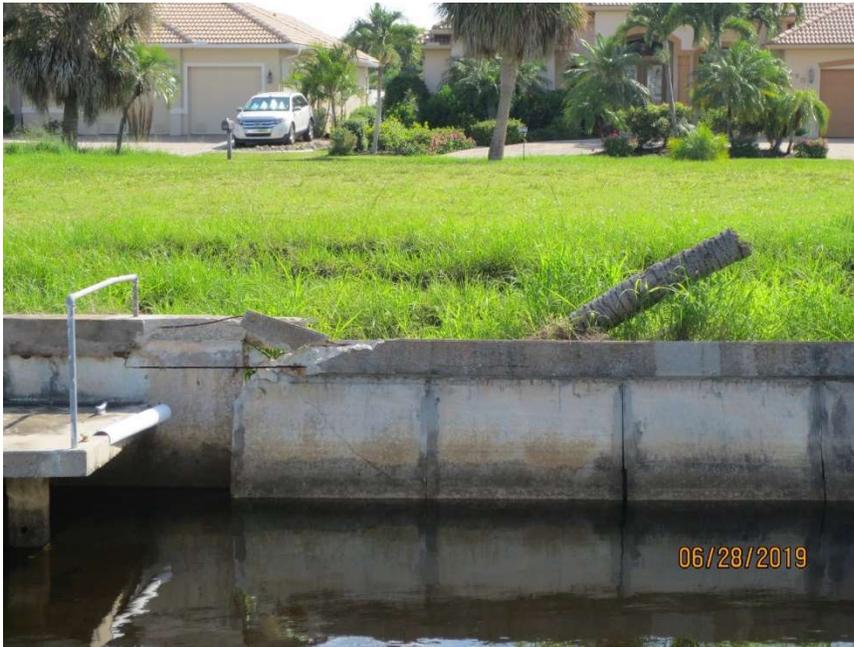
Location 19: 185 Gulfview Rd

Right: Seawall typical Irma failure (toe kicked out) to be replaced.

Large depression behind wall.

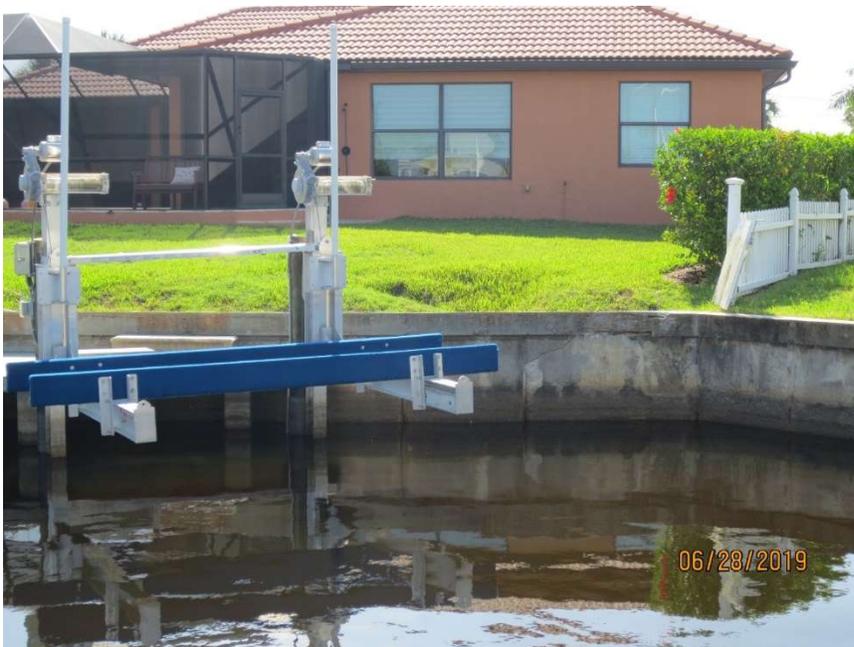
Location 19: 197 Gulfview Rd

Right: Large depression behind wall, panel crack and exposed rebar on cap.

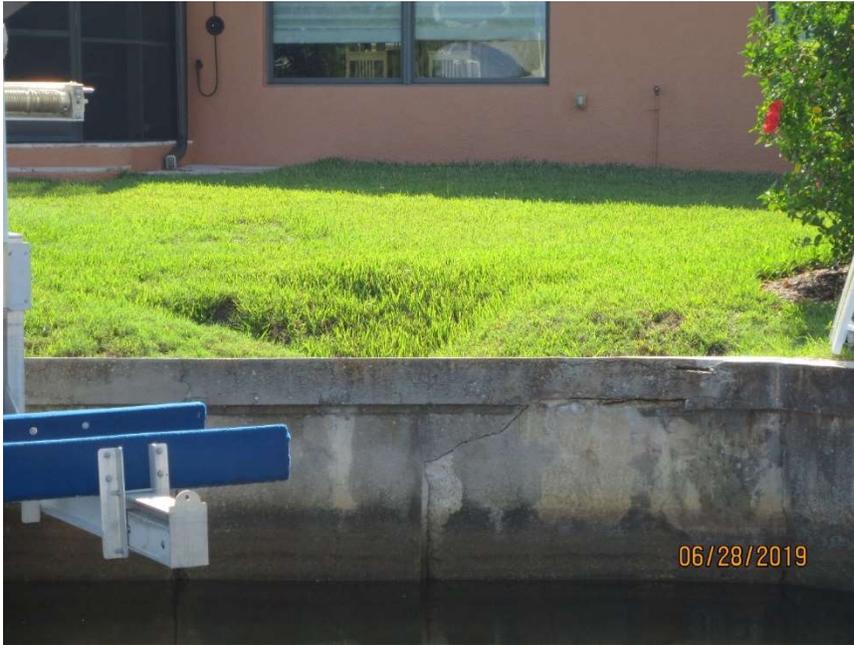
Location 19: 197 Gulfview Rd

Right: Large depression behind wall, panel crack and exposed rebar on cap.

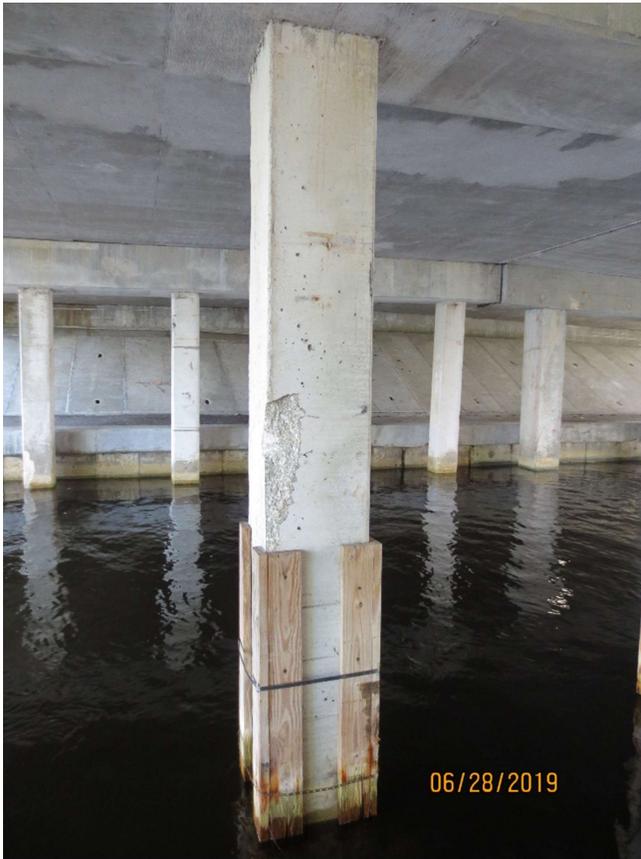
Location 21: West Marion Ave Bridge on PGI-NE1

Large spall on pile

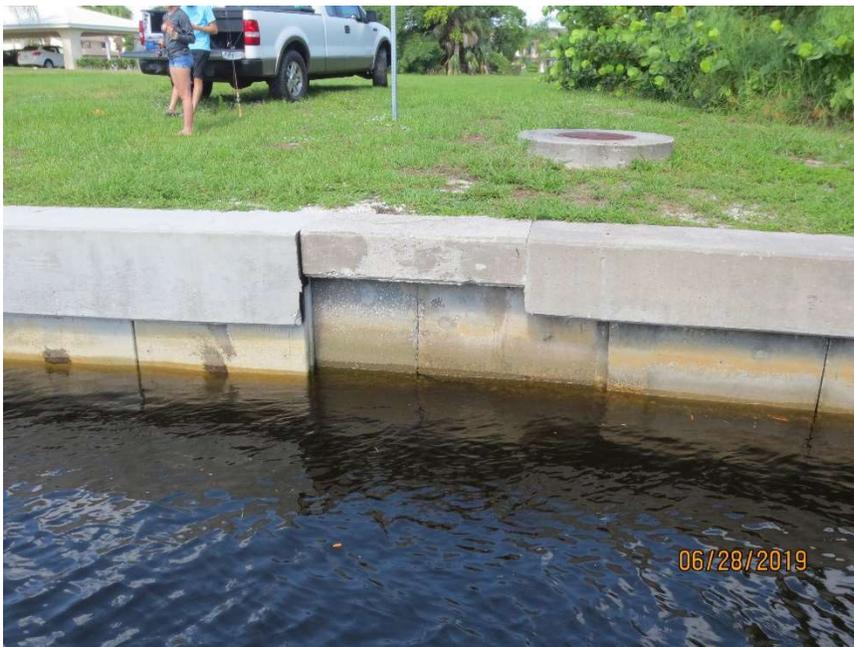
Location 21: West Marion Ave Bridge on PGI-NE1

New wall in front of the old wall, missing section on outflow pipe location

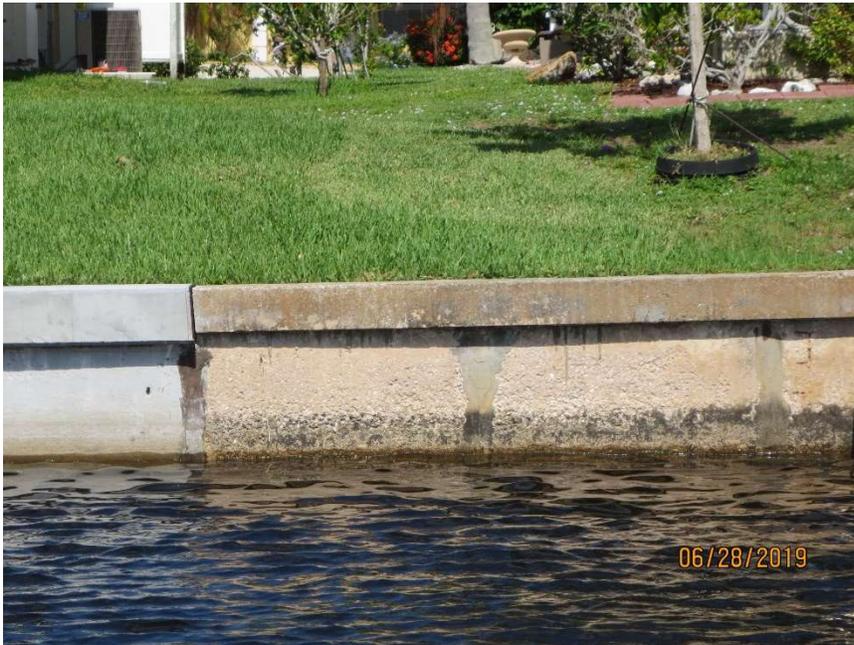
Location 23: 410 Medici Ct

Surface abrasion sets the overall condition to fair.

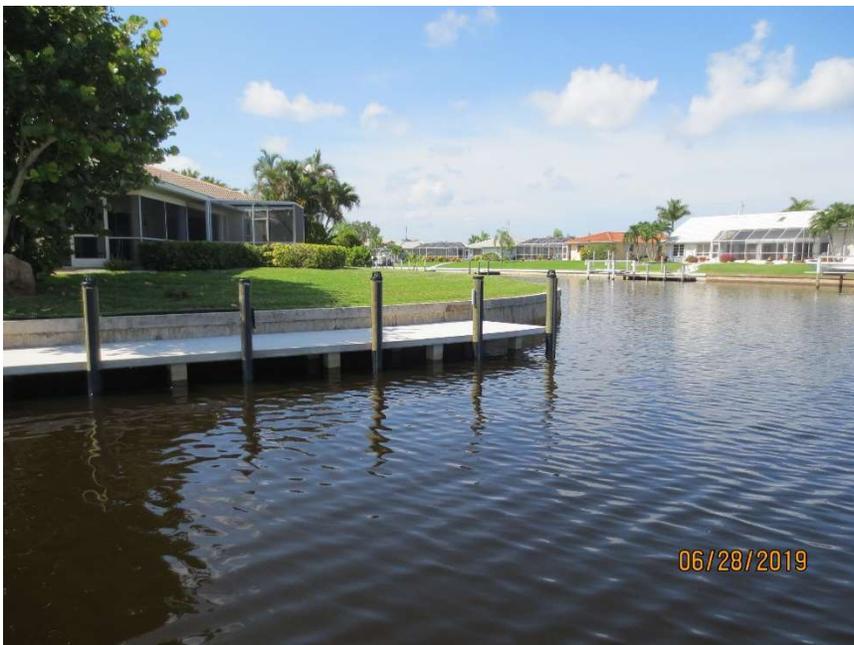
Location 24: 1036 Francesca Ct

Seawall with Moderate Rating since wall is leaning landward. It might have been built that way since it is a corner lot.
