Seawall Materials & Methods Feasibility Study City of Punta Gorda, Florida

Final Report
March 2021

Taylor Engineering, Inc.
1800 2nd St, Ste. 714
Sarasota, Florida 34236
(941) 702-5871

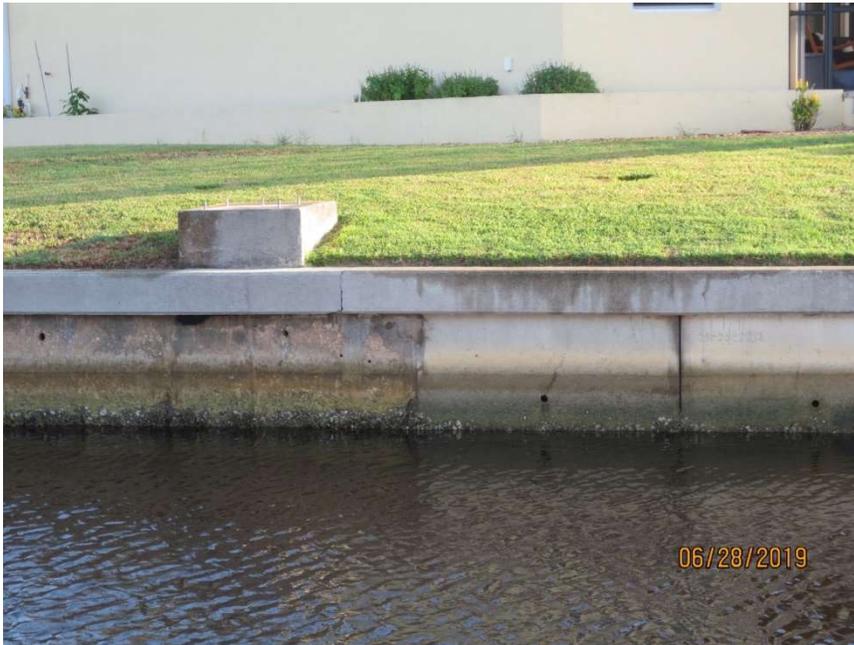
Location 1: 2803 Sancho Panza Ct

Left: Original Panels with Epoxy Coated Rebar Cap Replacement

Right: 1st Generation MMFX, 2012 (lower weep hole, prior Irma)

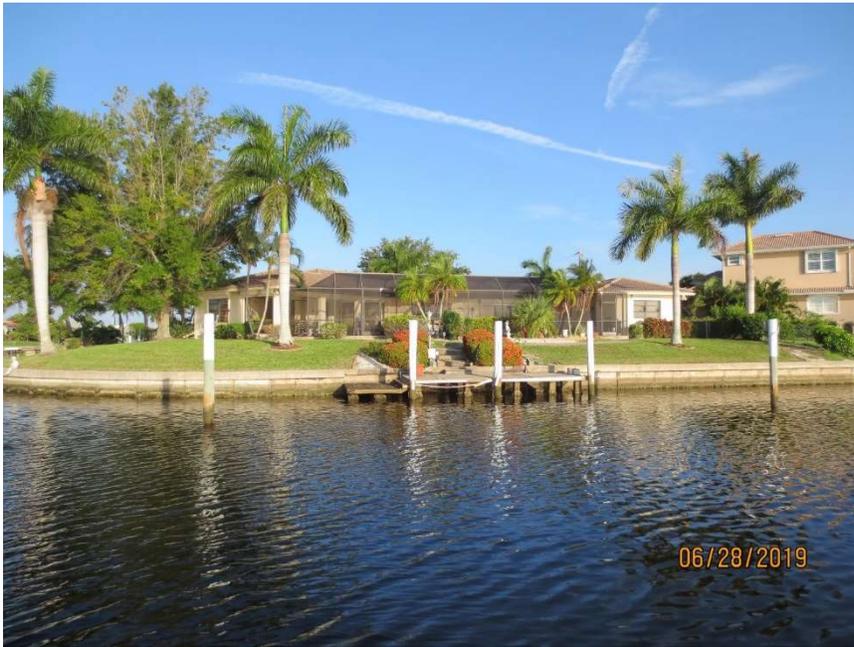
Location 3: 2803 Via Paloma Dr

Left: Epoxy Coated Rebar Seawall 2012;

Middle: Original Seawalls Behind Dock

Right: 2 Panels of Epoxy Coated Rebar Seawall 2012

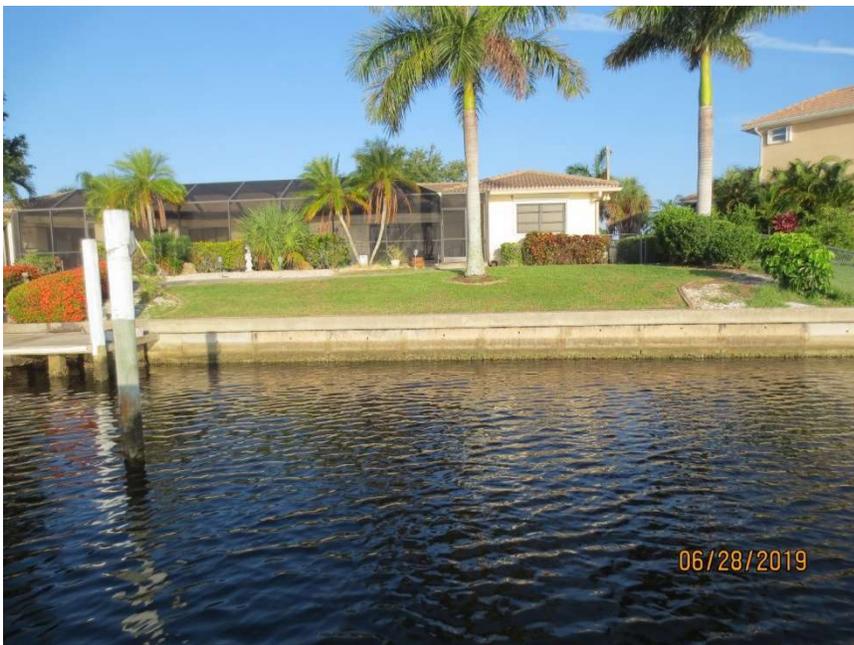
Location 3: 2803 Via Paloma Dr

Far Right: Original Seawall with Newer Cap

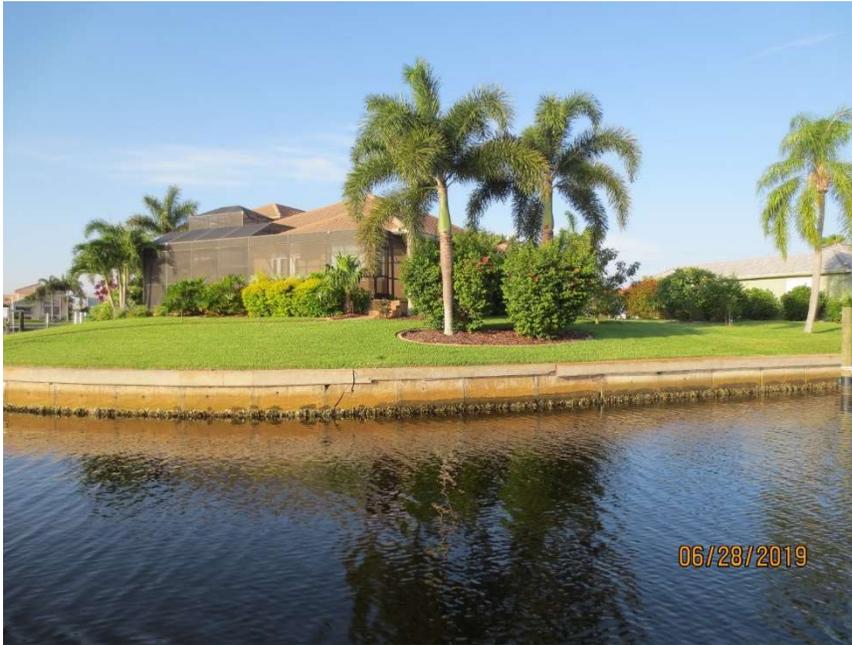
Location 4: 2800 Via Paloma Dr

Left: Original Panels with Newer Cap

Larger Caps used to stop in the middle of an old panel. Typical panel breakage occurred at these locations because differential loading. Now new Cap installation ends where new installation ends to avoid further damage to the panel.

Right: Panel union void below grout patch

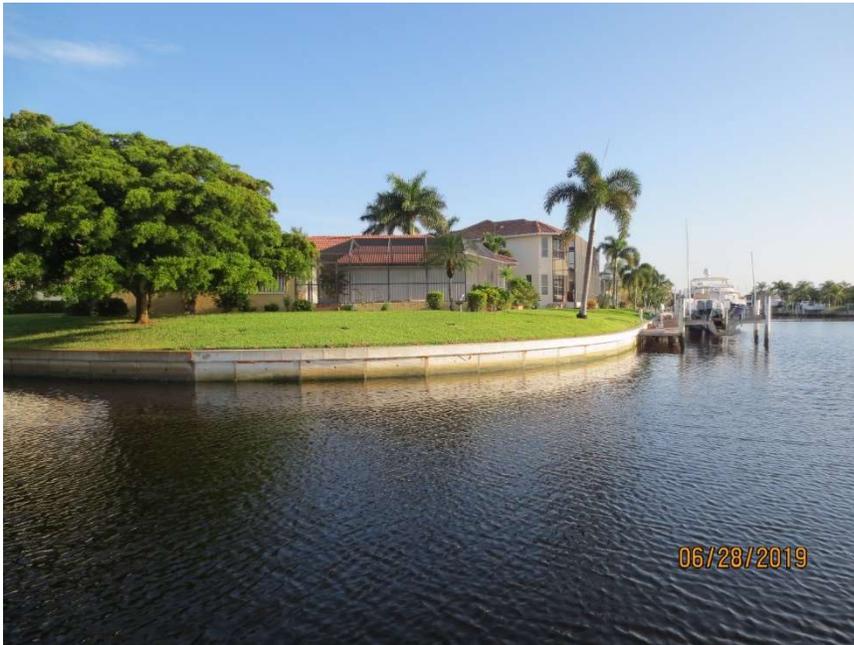
Location 5: 260 Lido Dr

Irma walls installed by Duncan Seawall

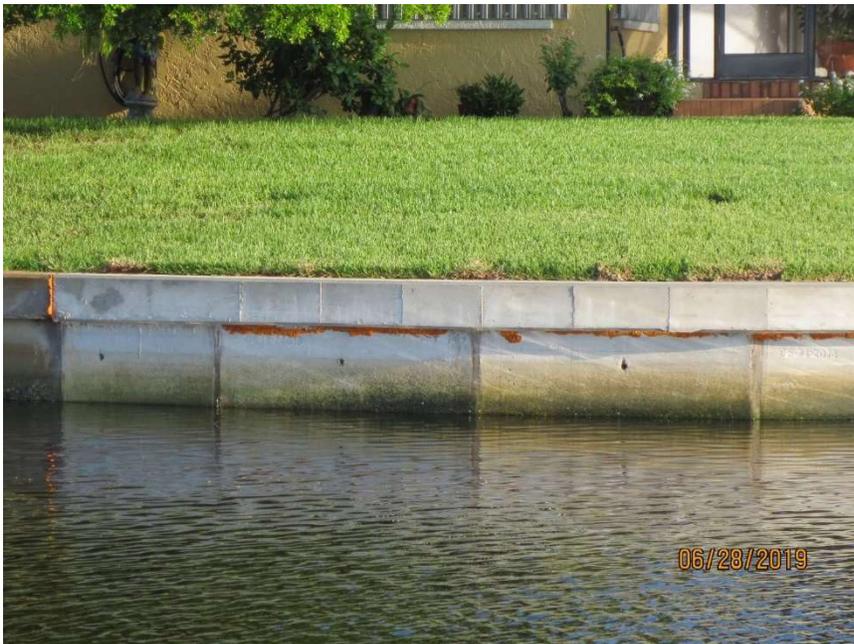
Location 5: 260 Lido Dr

Irma walls installed by Duncan Seawall

Note the expansive foam used between cap and form

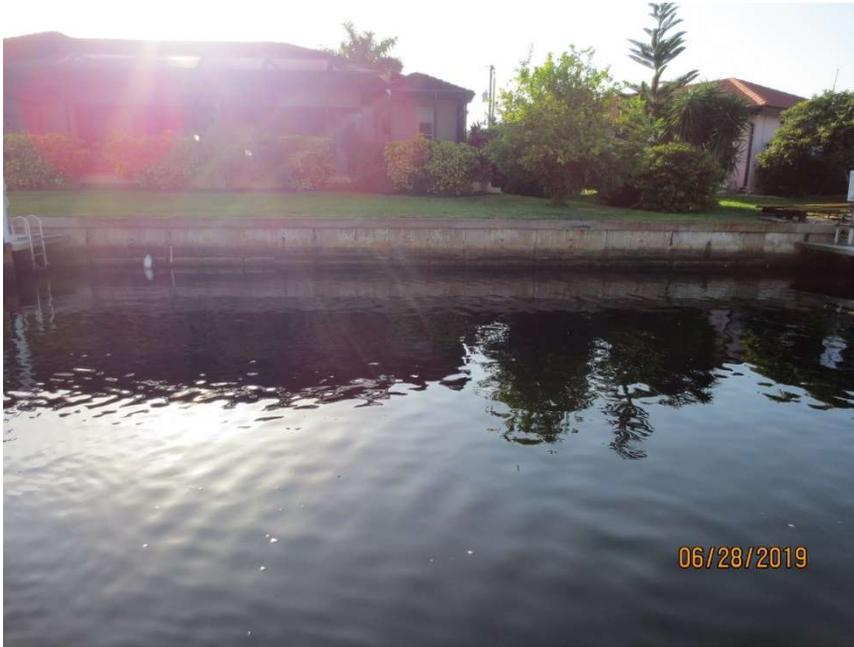
Location 6: 257 Lido Dr

Original 1971 wall in good shape

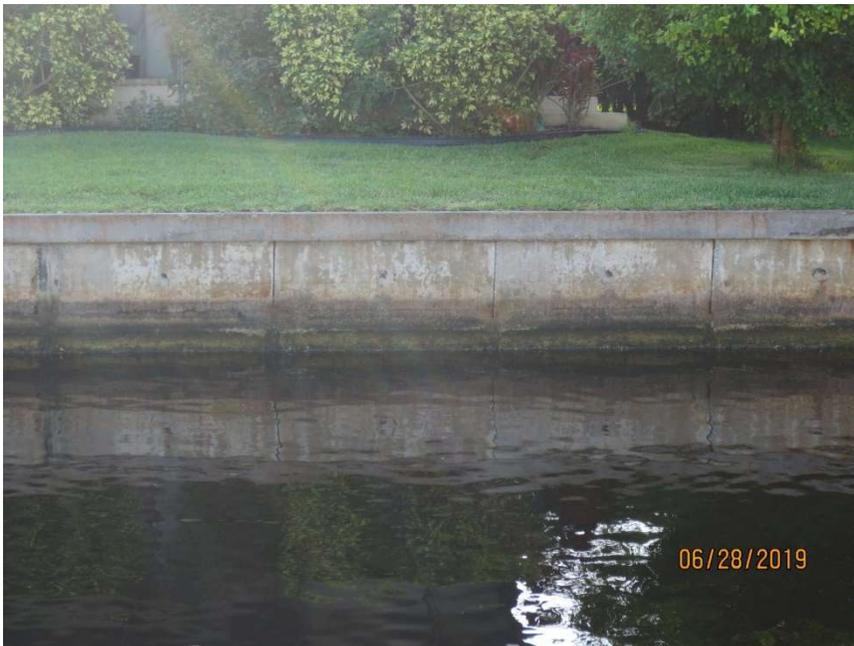
Location 6: 257 Lido Dr

Original 1971 wall in good shape

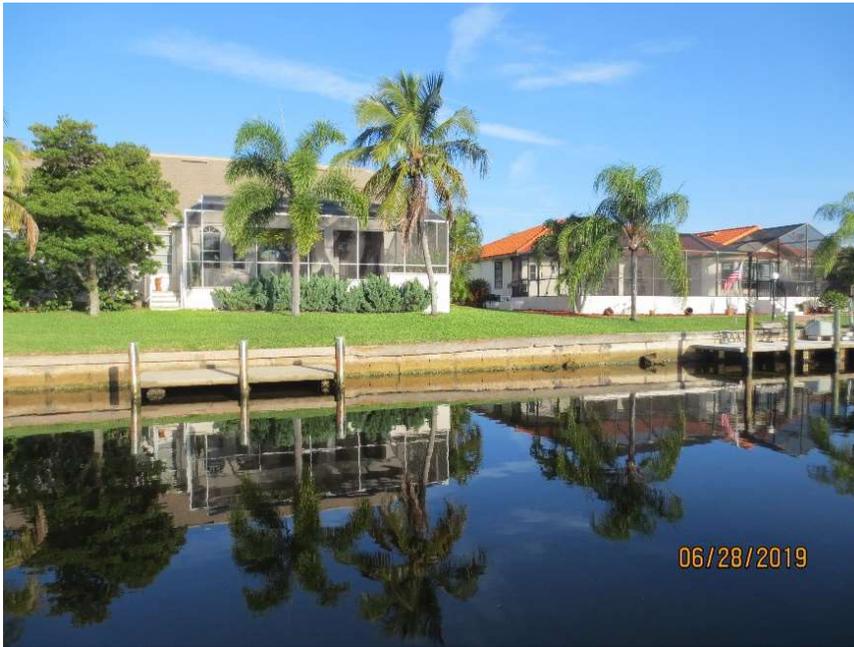
Location: West side of Divinci Dr Canal

Left: Original walls with lower elevation than newer installed walls on right

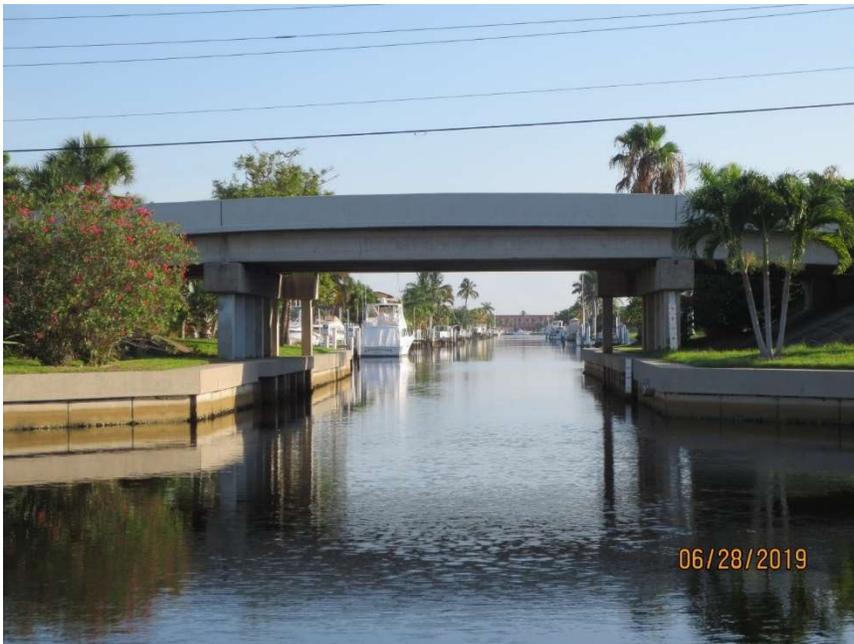
Location 7: West Marion Bridge on PGI-NW1 facing north

Deep spot about 26 feet.

Panels are 16-ft long and do not have enough penetration.

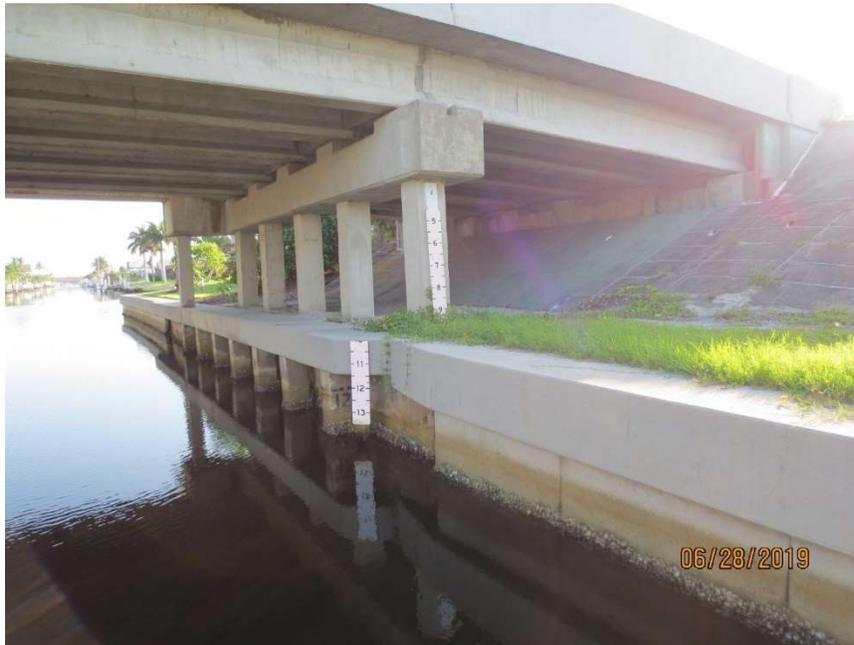
Location 7: West Marion Bridge on PGI-NW

Super Cap holding both walls together

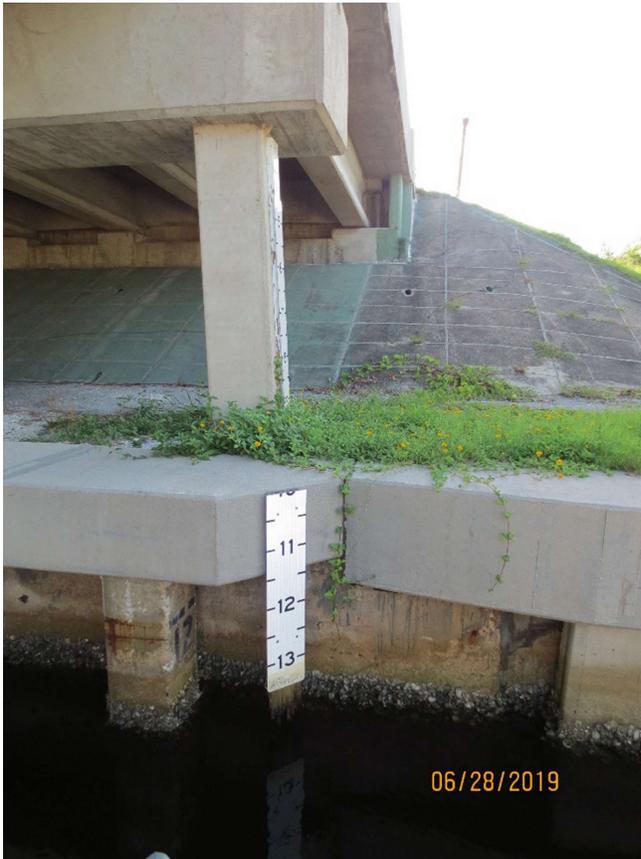
Location 7: West Marion Bridge on PGI-NW

Piles were driven in front of 16-ft panels for support.

About 12-ft of clearance during normal high tide

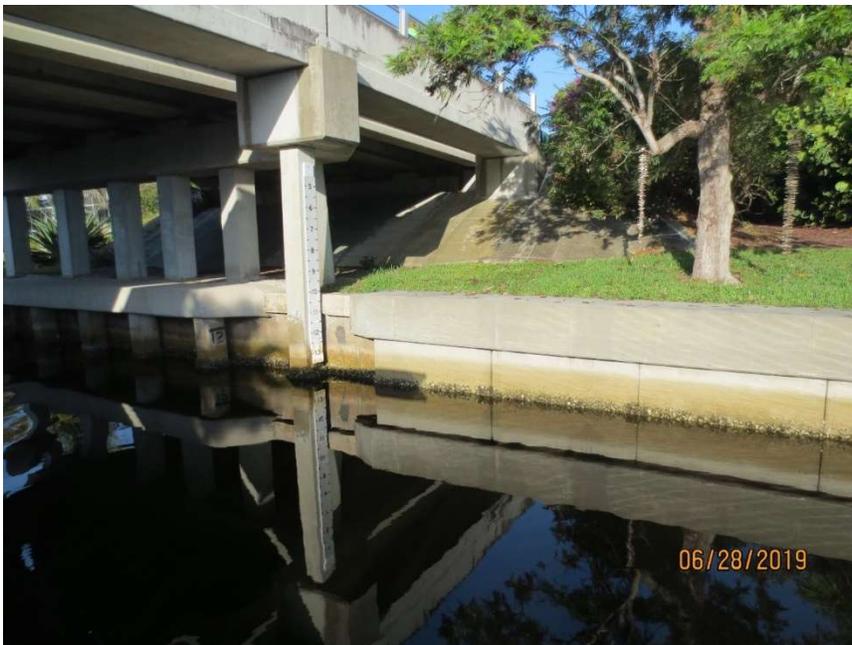
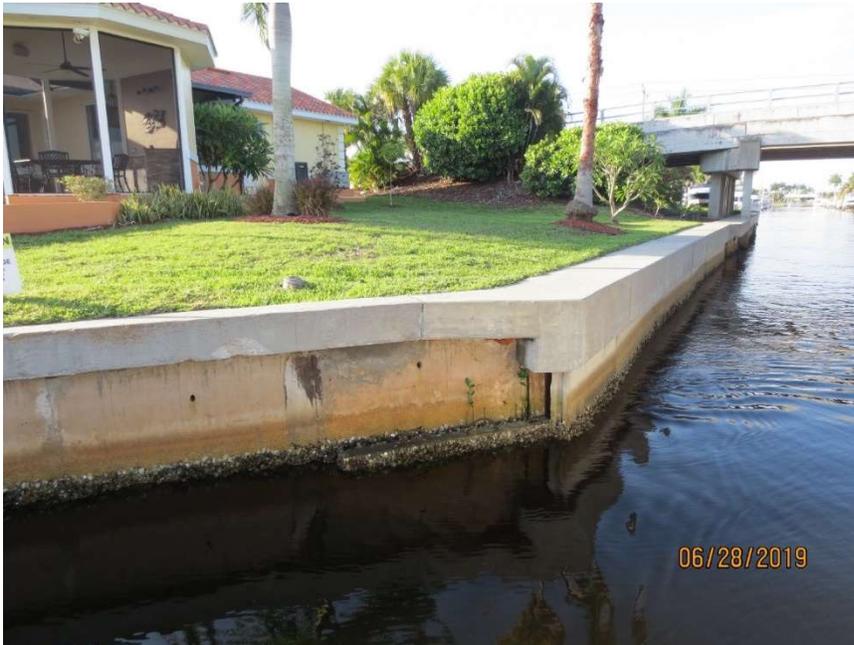
Location 7: West Marion Bridge on PGI-NW

Right: Super Cap holding both walls together

Left: Shorter panel driven in front of original wall for support.

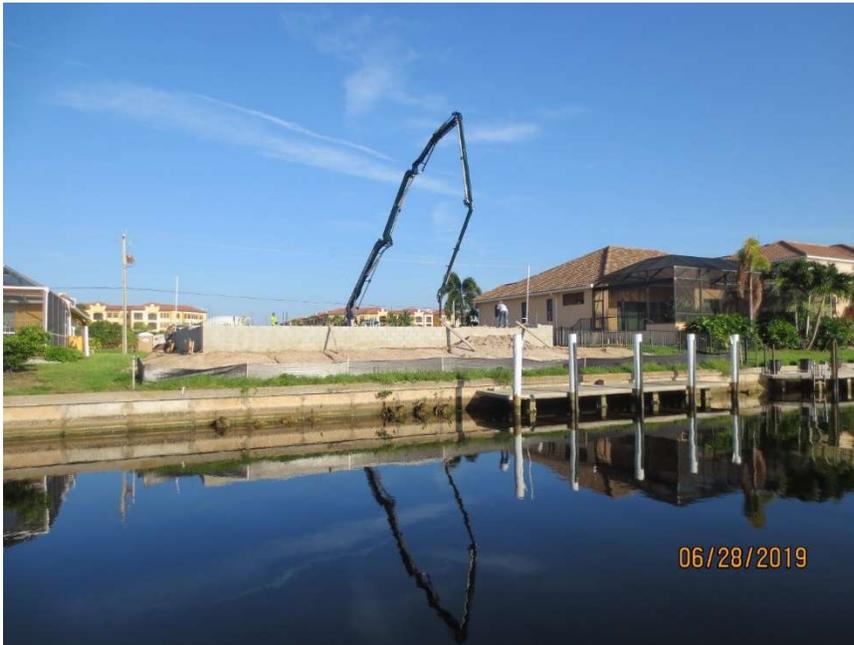
Location 9: 158 Colony Point Dr

New house construction with original wall left in place.

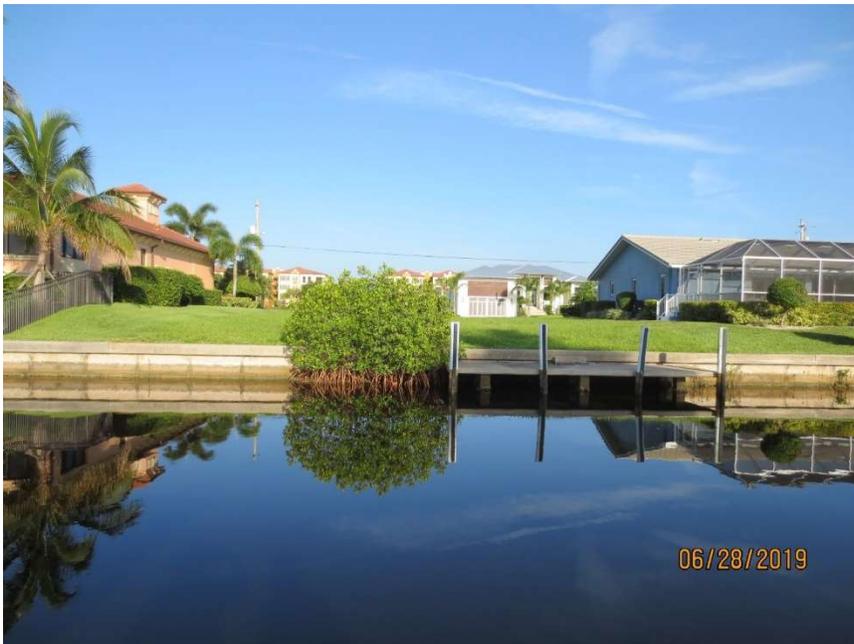
Location: Northwestern canal of PGI-NW1

Mangroves grow usually 18-inches a year. PGI mangroves grow faster than that, possibly due to nutrients in the water.

The City trims mangroves under an exemption provision of Statute FS403.9326 Exemptions (d).

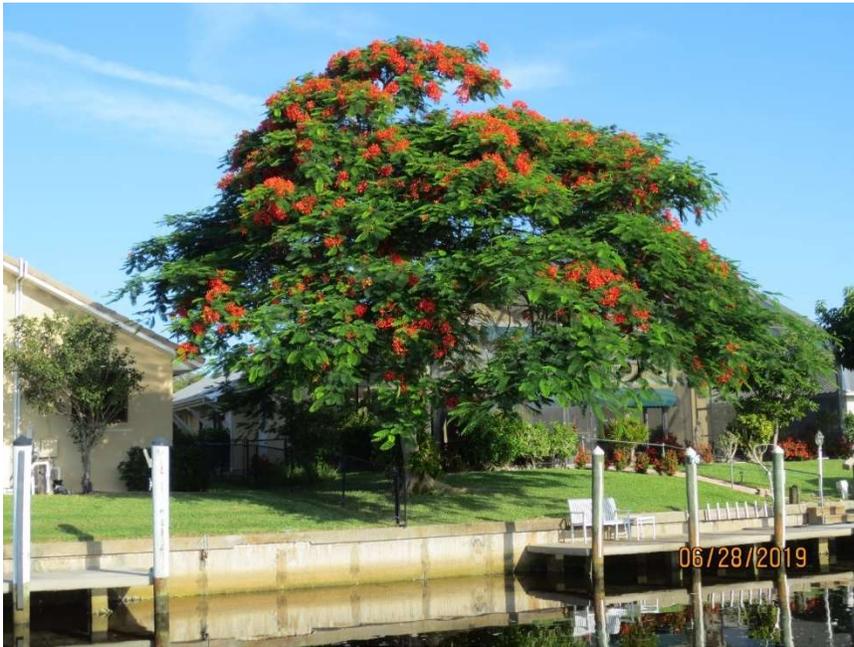
Location: Northwestern canal of PGI-NW1

Large Poinciana tree within 10-ft of the seawall

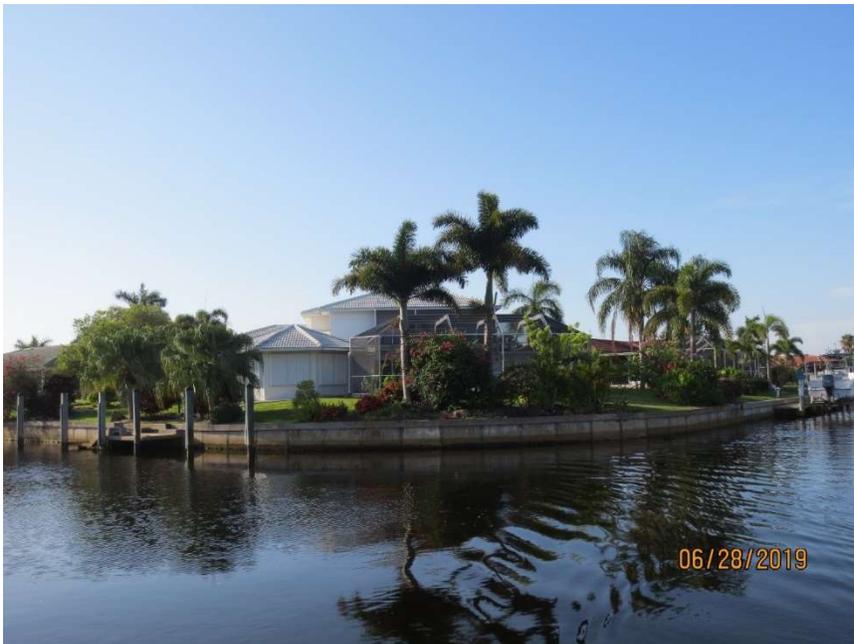
Location: 2790 Rio Ct

Large landscape within 10 -ft of the seawall is not allowed by City ordinance

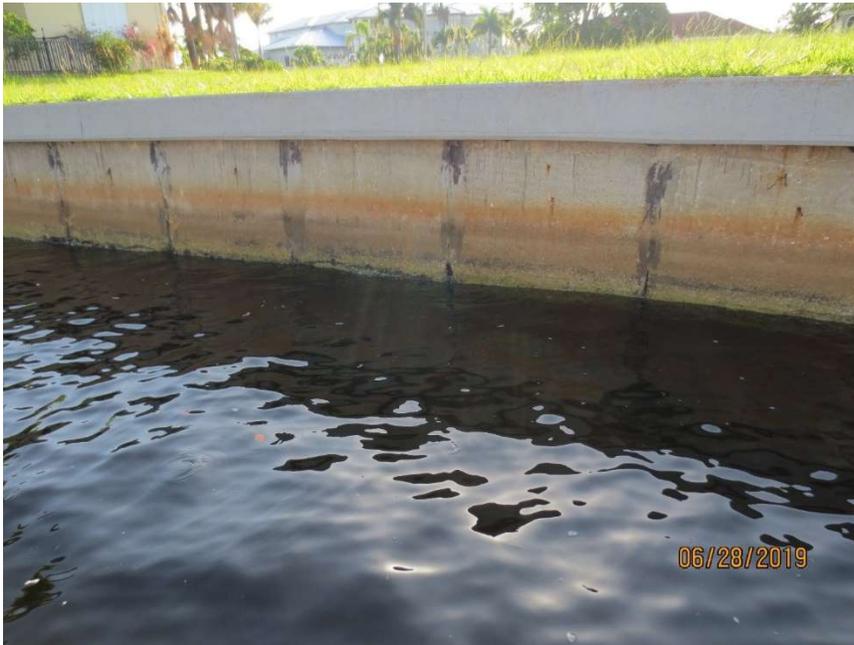
Location 10: 7 Hibiscus Dr

Newer Cap with Epoxy Coated Rebar built on original panels

Severe Rating, Crack by waterline, Panel unions grouted to waterline

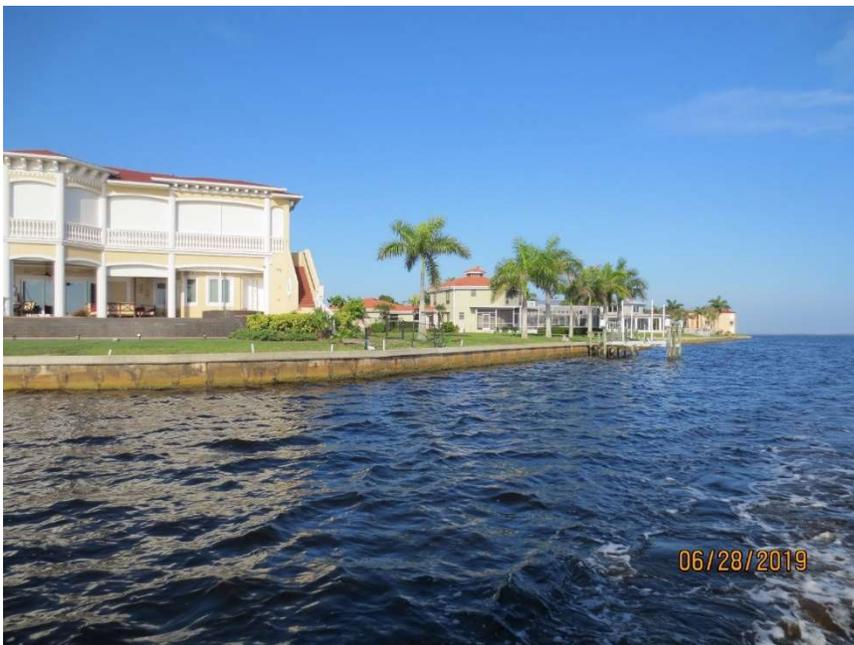
Location: 2 Tropicana Dr

Original panels with Epoxy Coated Rebar facing the Peace River bay

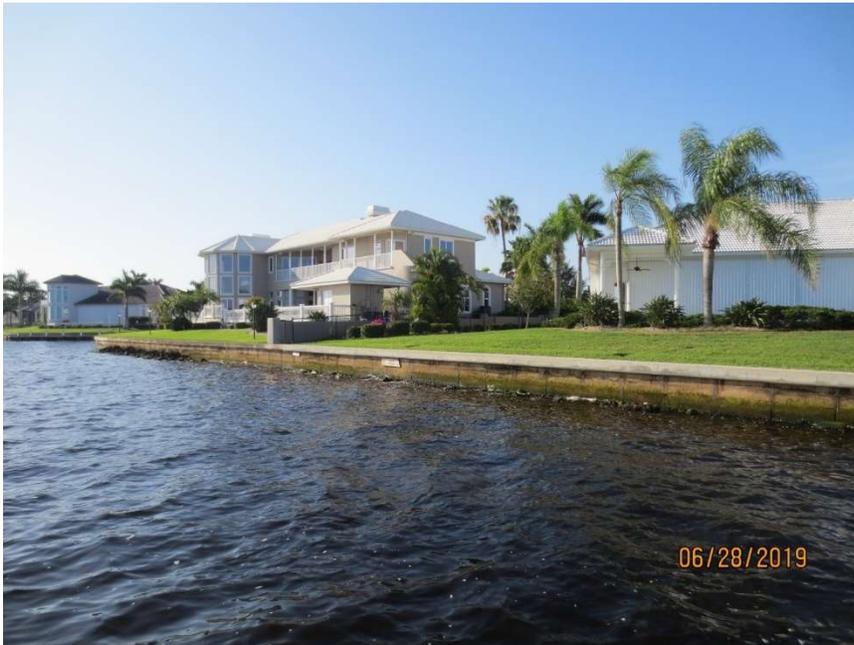
Location: 4 Sabal Dr

Rip Rap exposed and submerged along the seawall

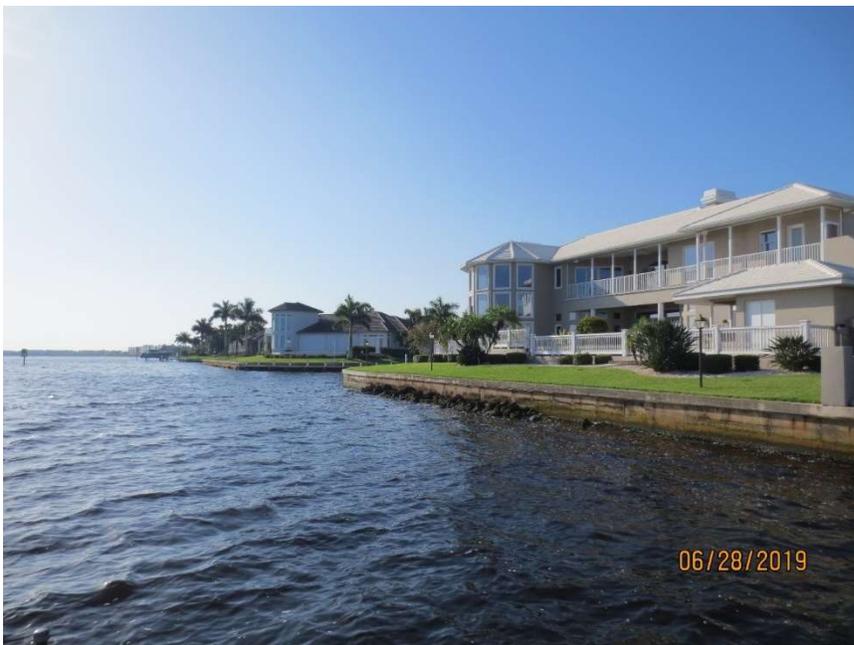
Location: 4 Sabal Dr

Rip Rap exposed in front of wall

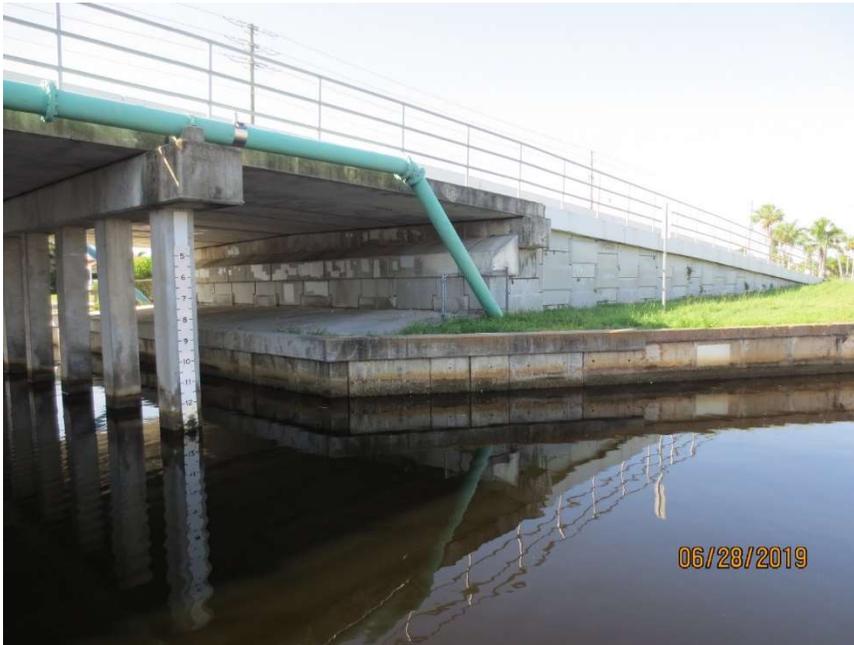
Location 14: West Marion Ave Bridge on PGI-NW2 facing south.

Small width panels possibly installed by FDOT

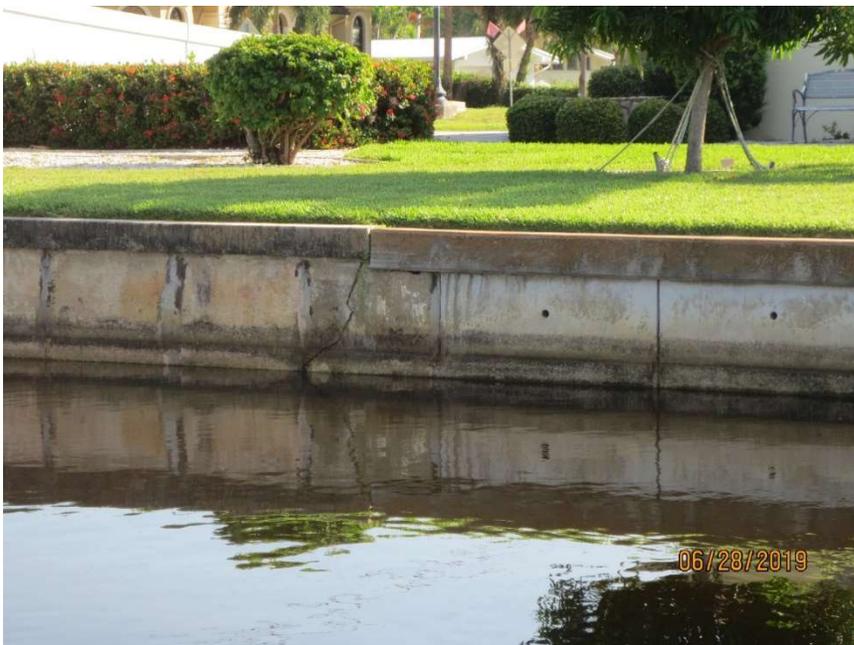
Location 14: 2001 W Marion Ave

Left: Original Seawall

Right: Epoxy Coated Rebar seawall with cap extending over old wall cracking panel below.

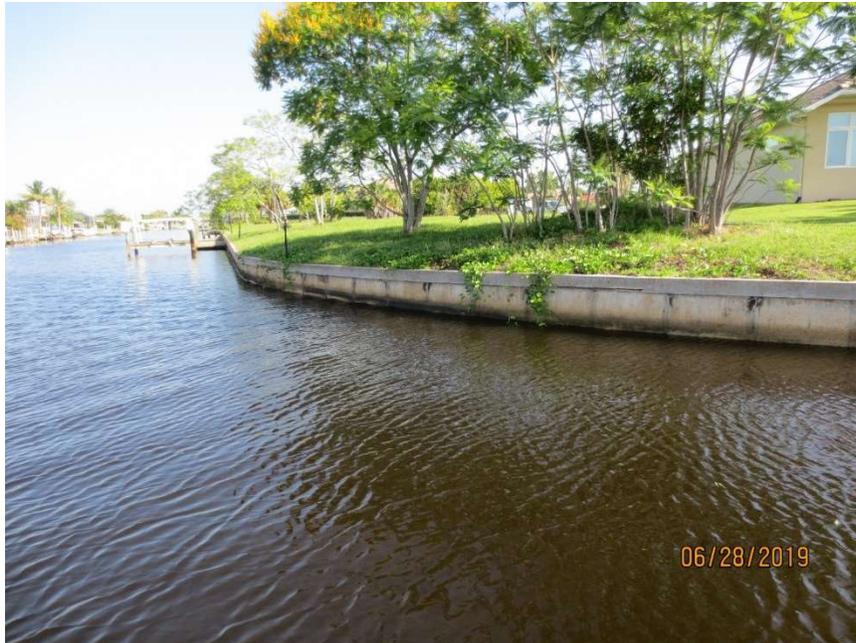
Location 15: 1793 Belle Ct

Left: Original Seawall with lower elevation

Right: Cap rebar exposed most of the seawall on the south and west end of the property.

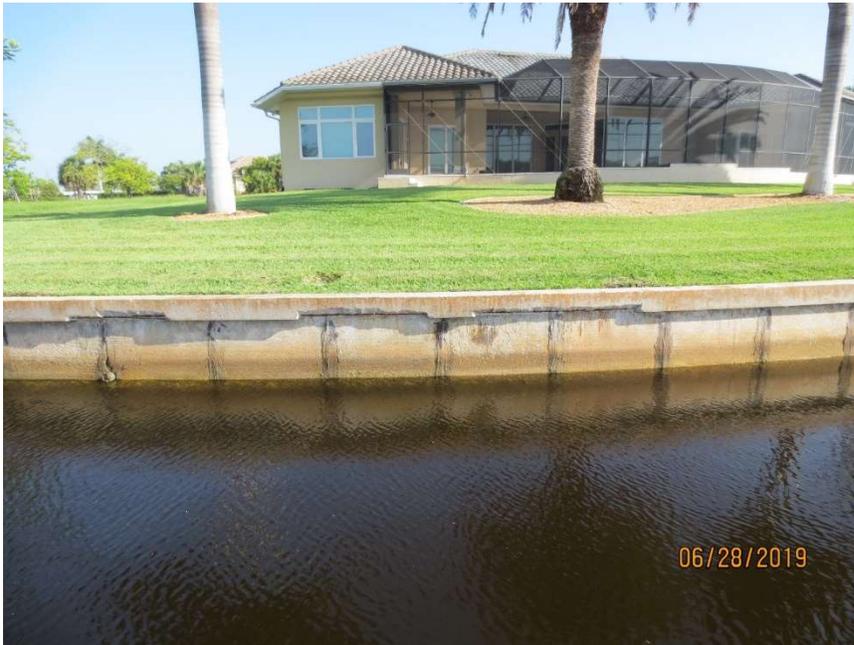
Location 15: 1793 Belle Ct

Cap rebar exposed on south end of property.

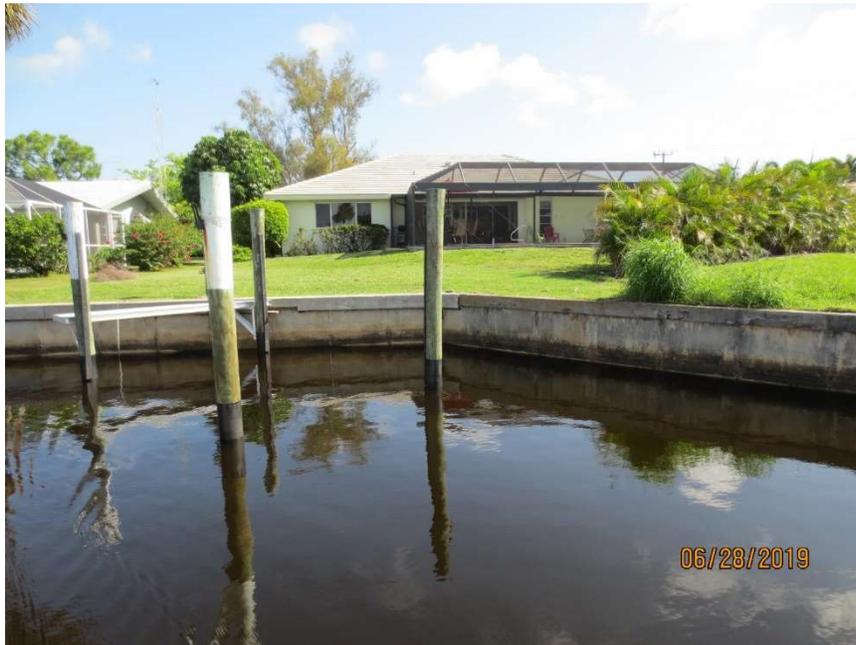
Location 19: 185 Gulfview Rd

Right: Original seawall north side of the property.

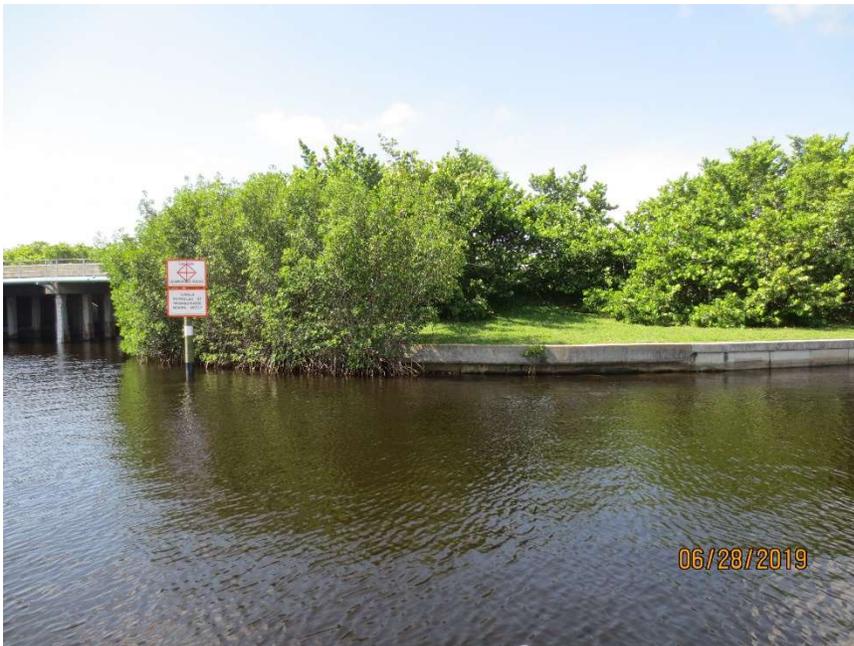
Location 21: West Marion Ave Bridge on PGI-NE1

Mangrove growth and super cap on original seawall

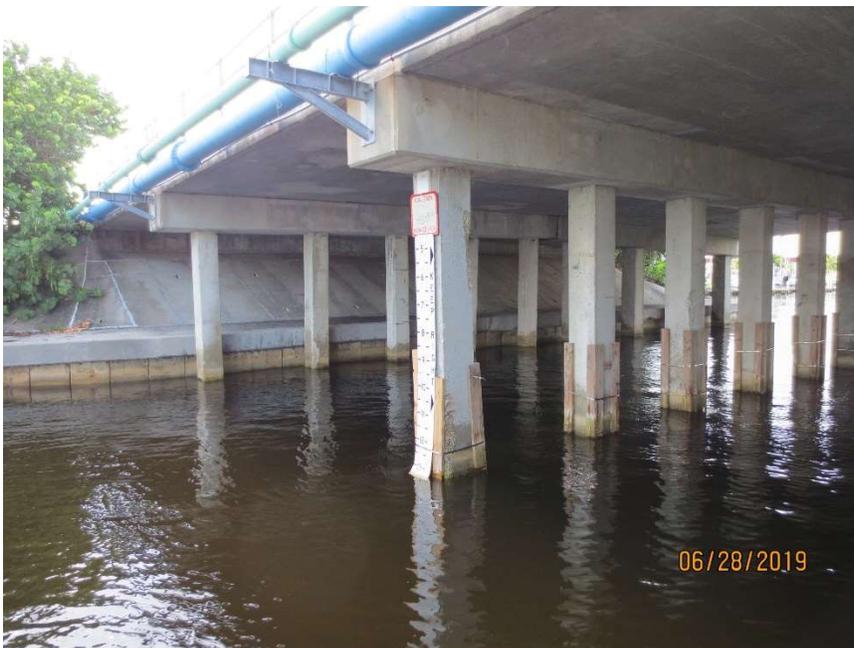
Location 21: West Marion Ave Bridge on PGI-NE1

Timber to protect piles from vessels.

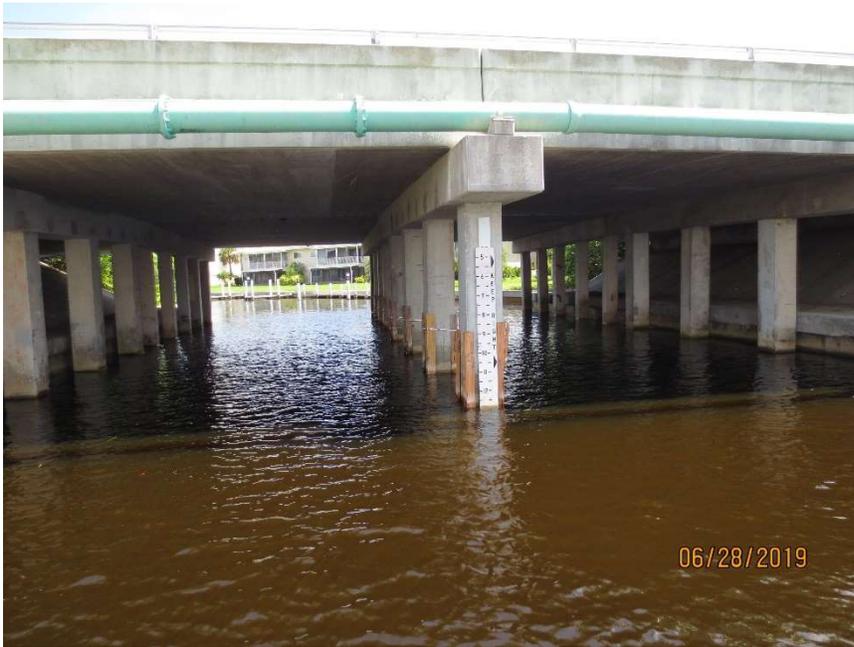
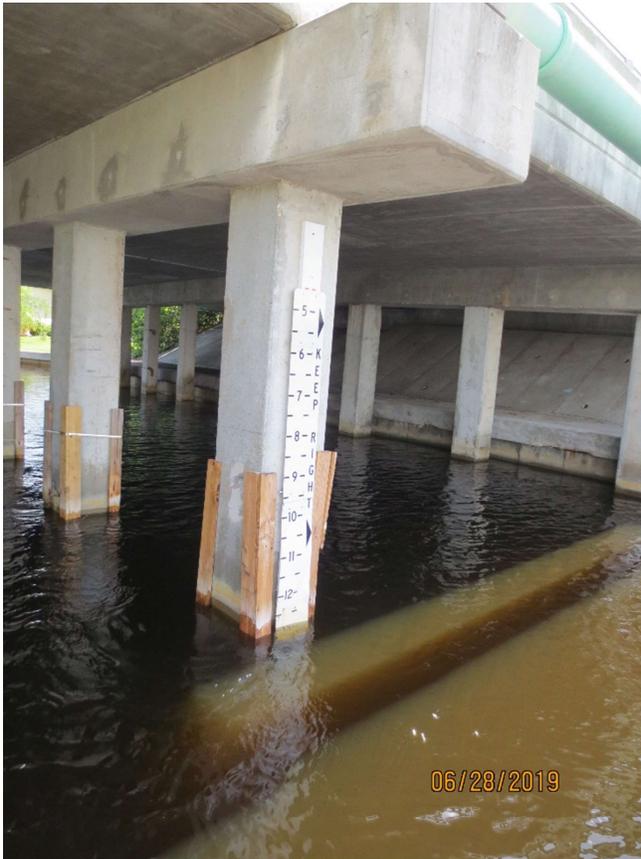
Location 21: West Marion Ave Bridge on PGI-NE1

A second bridge is located near the north end of the PGI-NW2 subdivision and has a vertical clearance of approximately 12-ft during the normal high tide. Taylor staff noted that some of the panels near the bridge abutment were about 2-ft wide. City staff stated that those panels were possibly installed by FDOT at the time of the bridge construction. Minor chips and spalls were observed on the prestressed concrete piles.

Large spall on pile

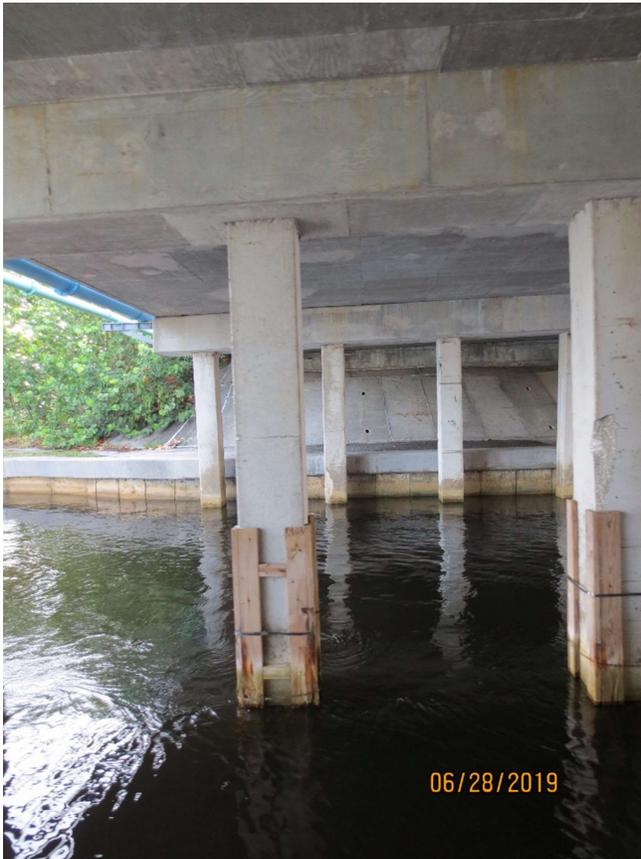
Location 21: West Marion Ave Bridge on PGI-NE1

New wall in front of the old wall, missing section on outflow pipe location

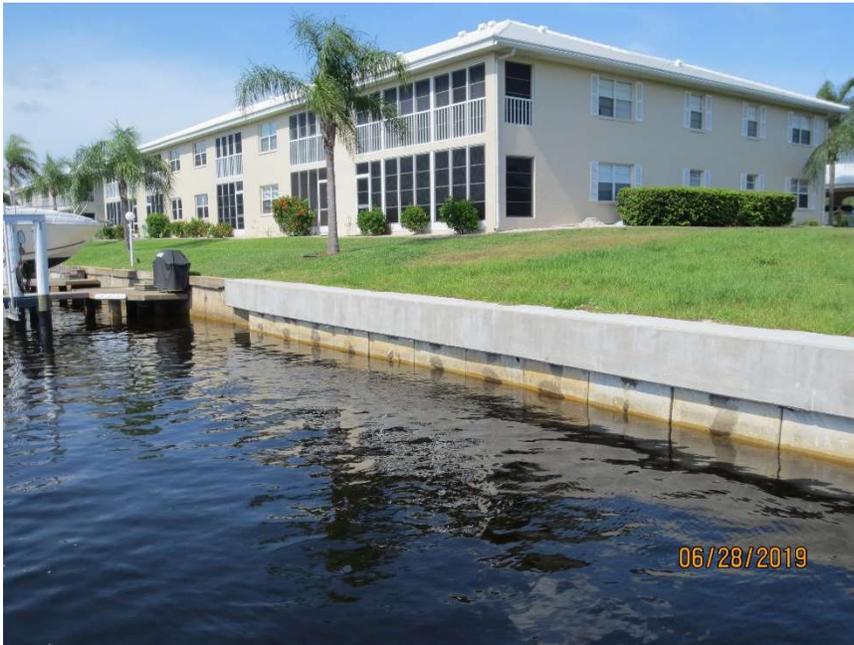
Location 21: West Marion Ave Bridge on PGI-NE1

Super cap on newer wall

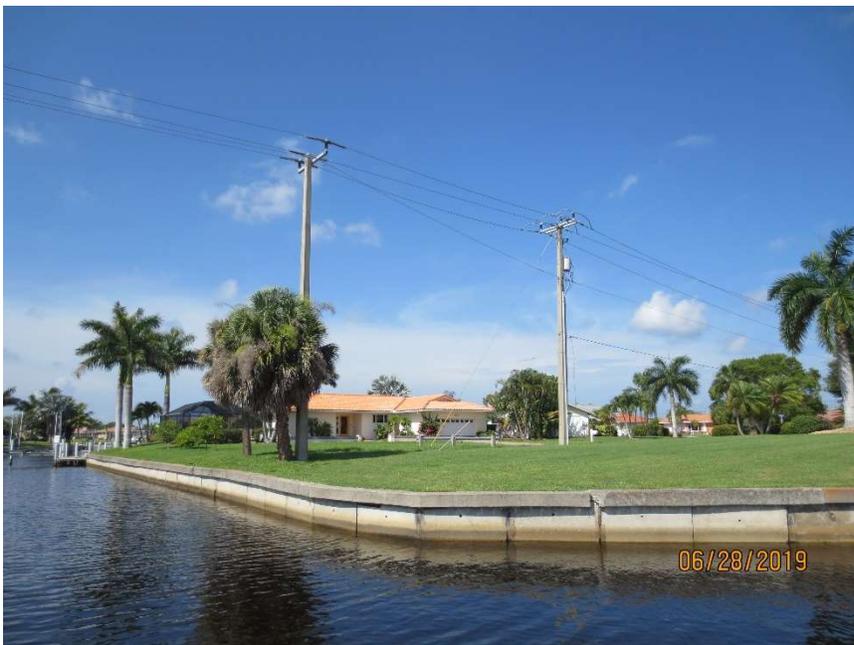
Location 22: 1200 Columbian Dr

City owned right of way at the end of the street for possible staging area, but there are power lines above.

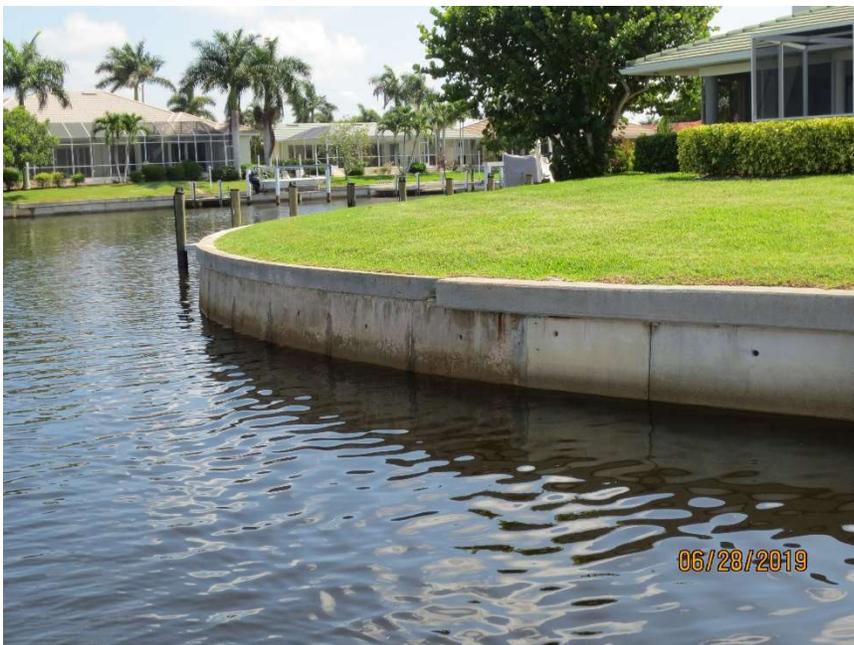
Location 24: 1036 Francesca Ct

Seawall with Moderate Rating since wall is leaning landward. It might have been built that way since it is a corner lot.

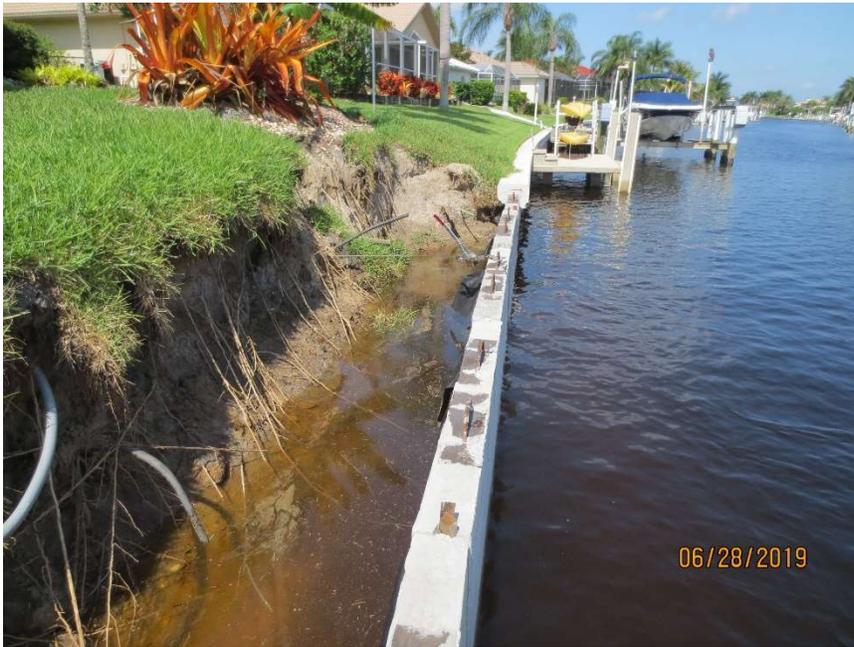
Location 26: 704 Vía Formia

Seawall construction. Panels

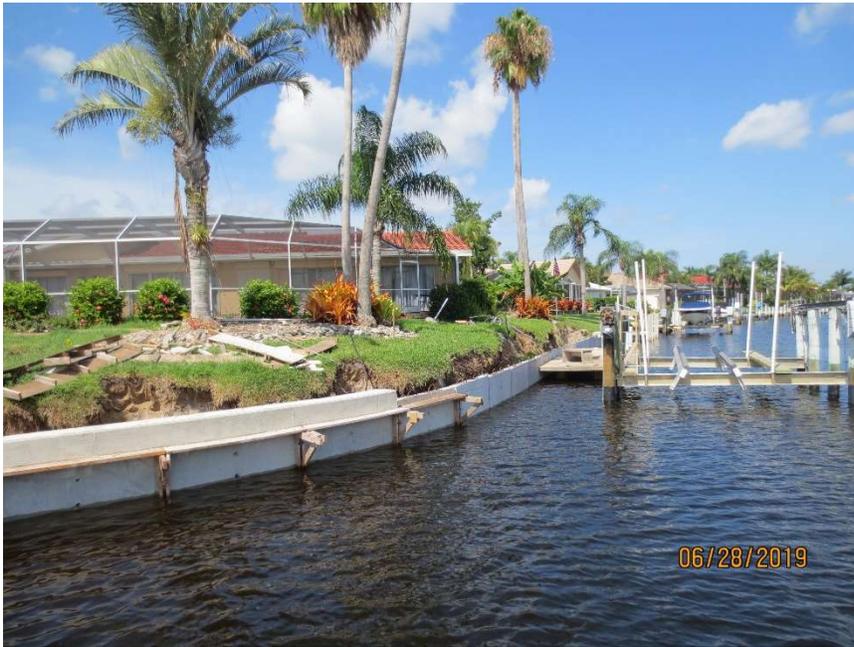
Location 26: 704 Vía Formia

Some old deadmen are possibly under the house foundation.

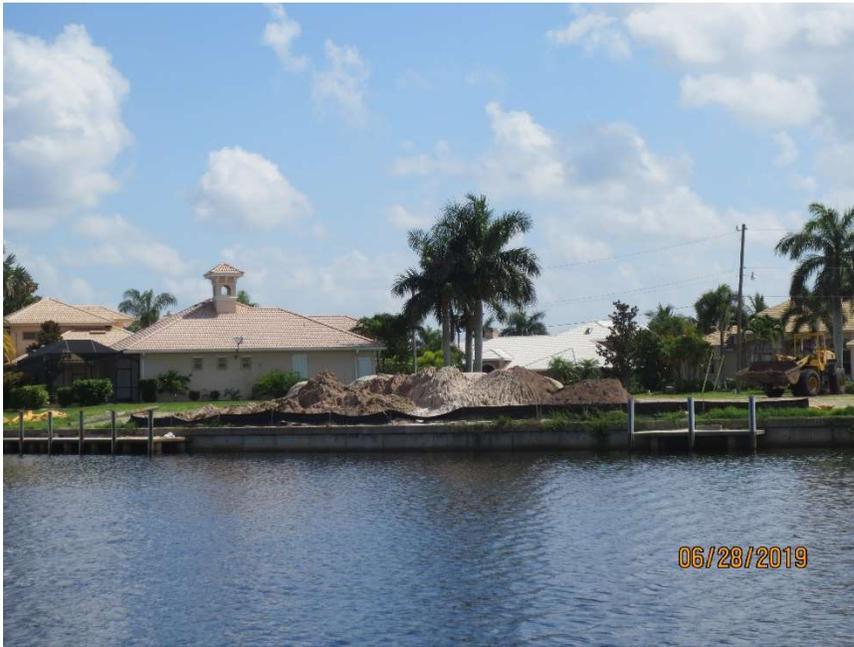
Location 27: 245 Freeport Ct

Staging Area

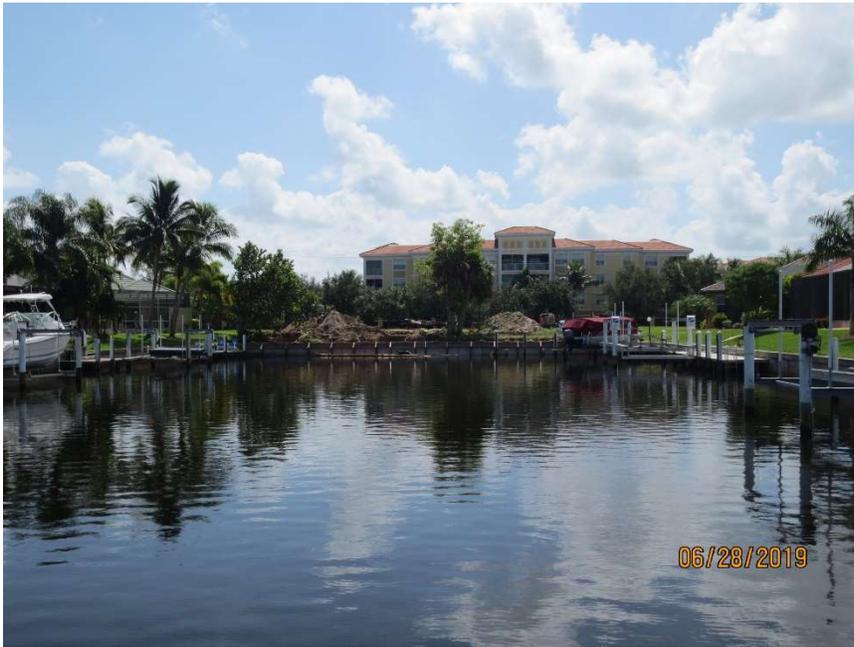
Location 28: 2227 Magdalena Dr

New construction, few new deadmen, outflow pipe set on top of over driven panel and form around and on top for concrete pour.
