Seawall Materials & Methods Feasibility Study City of Punta Gorda, Florida

Final Report
March 2021

Taylor Engineering, Inc.
1800 2nd St, Ste. 714
Sarasota, Florida 34236
(941) 702-5871

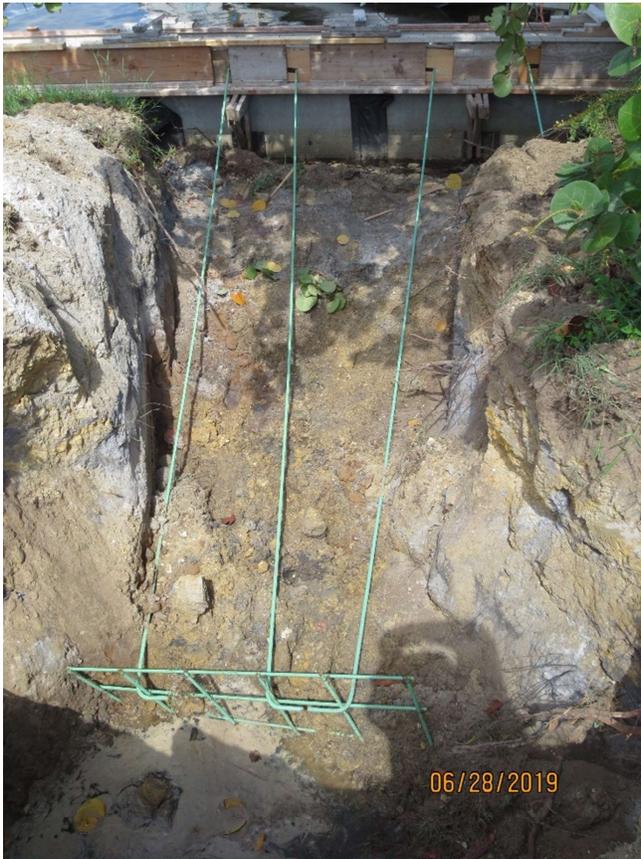
Location 28: 2227 Magdalena Dr

Concrete ready to be poured, no form placed.

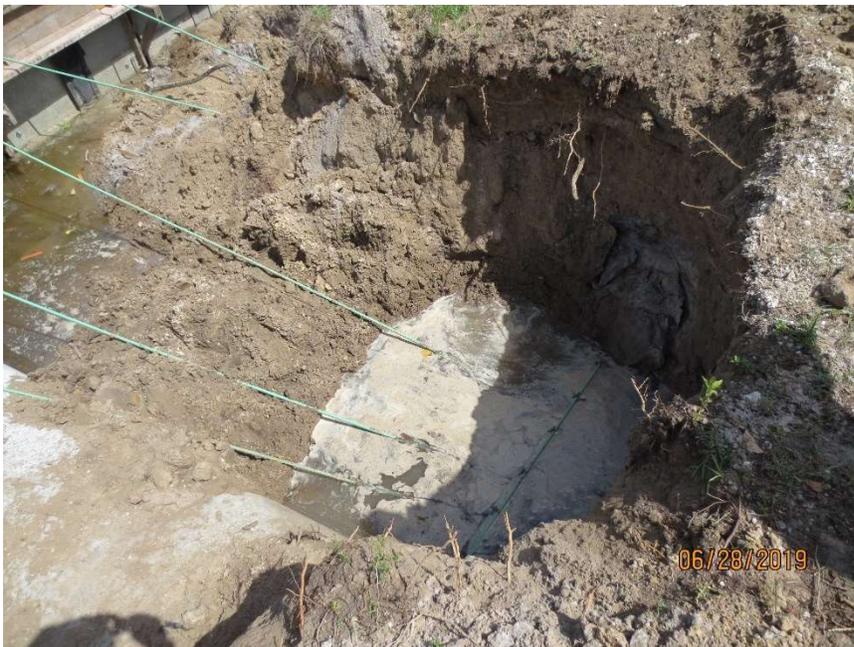
Location 28: 2227 Magdalena Dr

Concrete ready to be poured, dam created with soil.

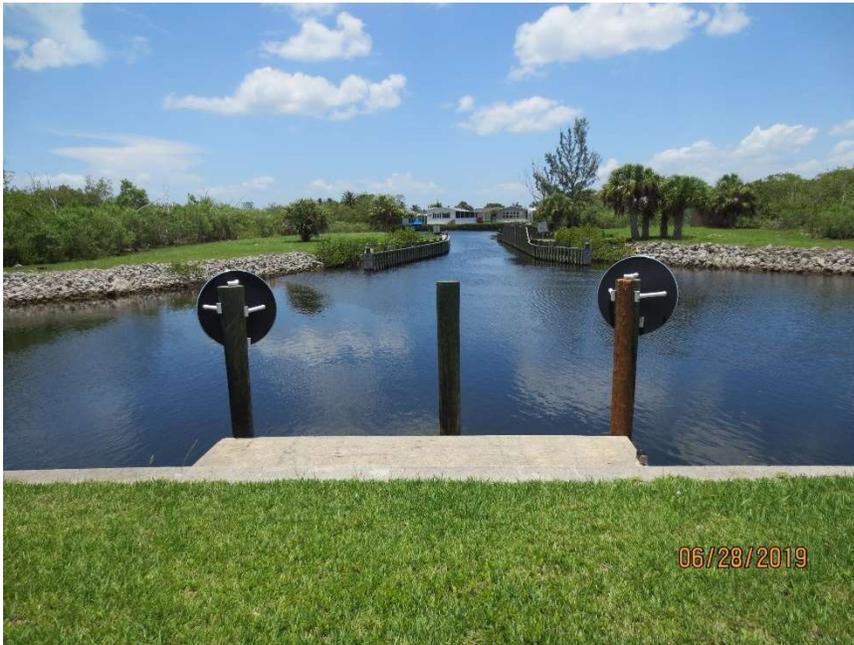
Location: 3713 Candia Dr

Looking at the BSI entrance lock (not in use).

Mirrors to see incoming boats. One boat at the time.
